Reusco, Inc. dba Housemaster

Inspection Date: 9/23/2005

INSPECTION INFORMATION

sample
Pittsburgh, Pa

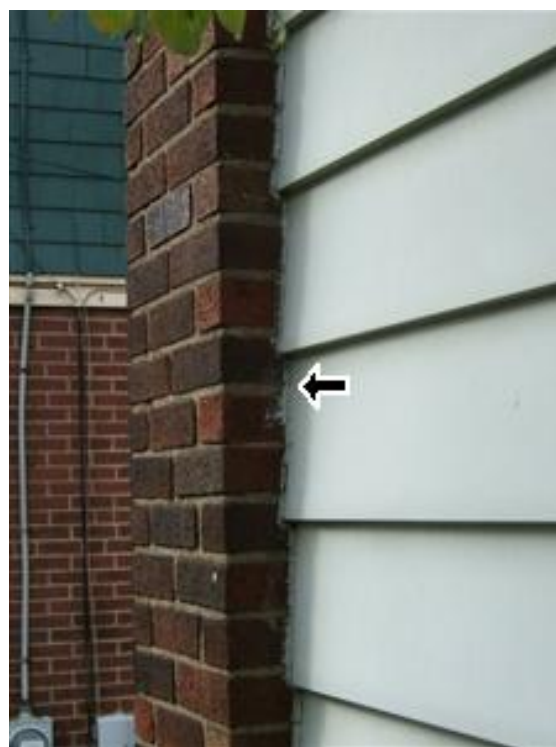
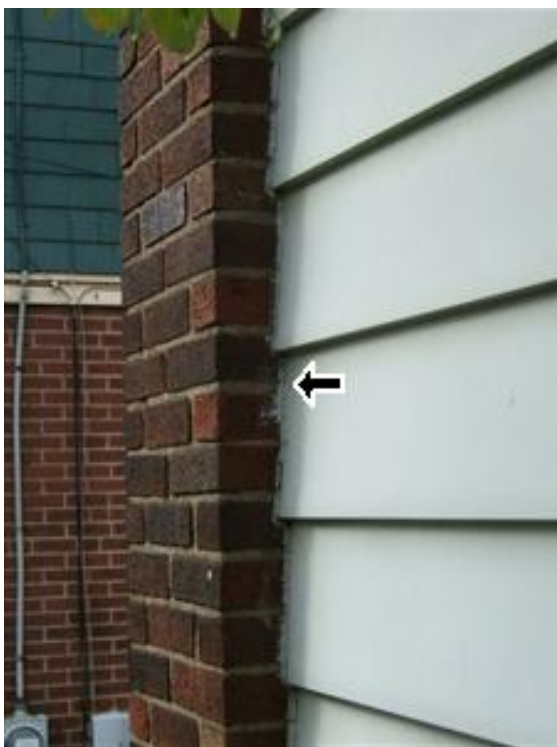
2.1 Siding 2 Picture 1

Worn or missing caulking in need of maintenance at some areas, Recommend repair or replacement as needed.

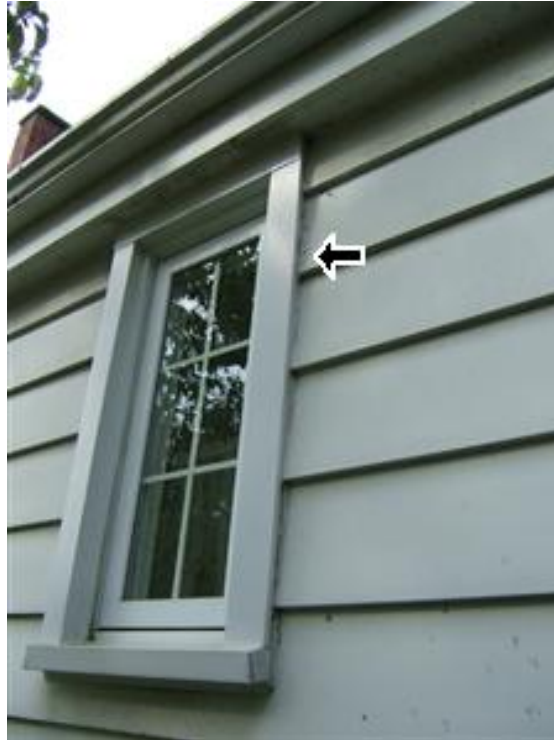
2.2 WINDOWS Picture 1

Worn or deteriorated/cracked caulking noted at some areas; Recommend repair of all as needed by a qualified contractor.

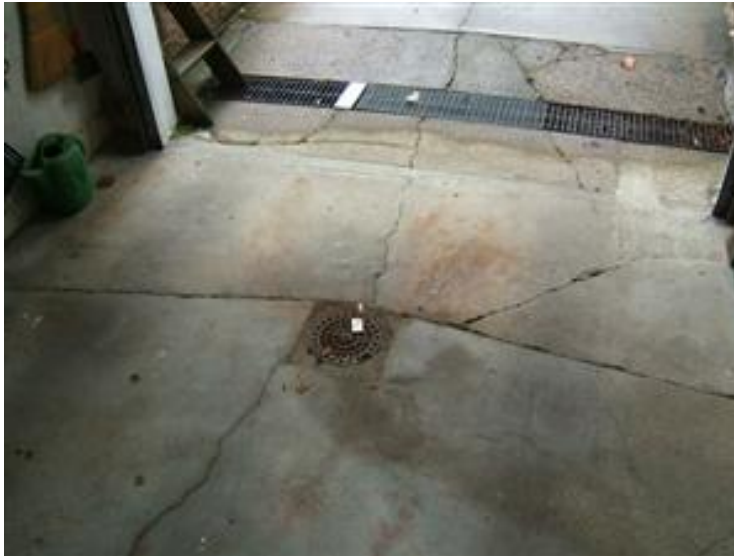
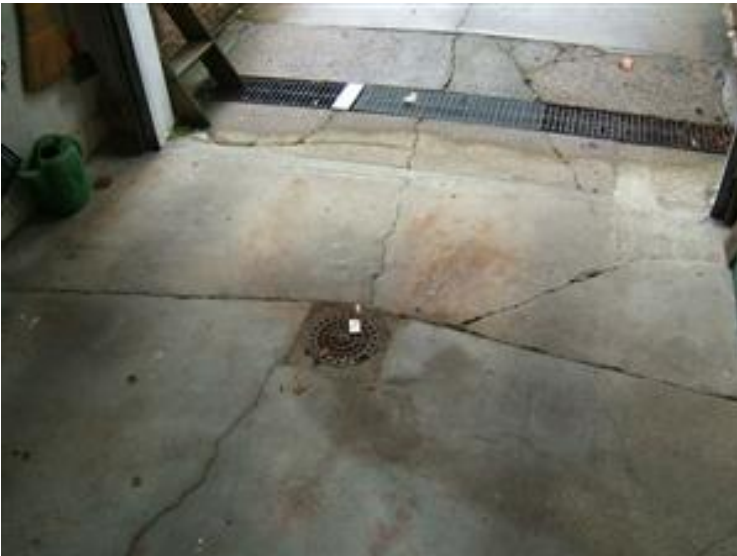
4.2 FLOOR SLAB Picture 1

Floor is heavily cracked/settled ; recommend repair/replacement by a qualified contractor.

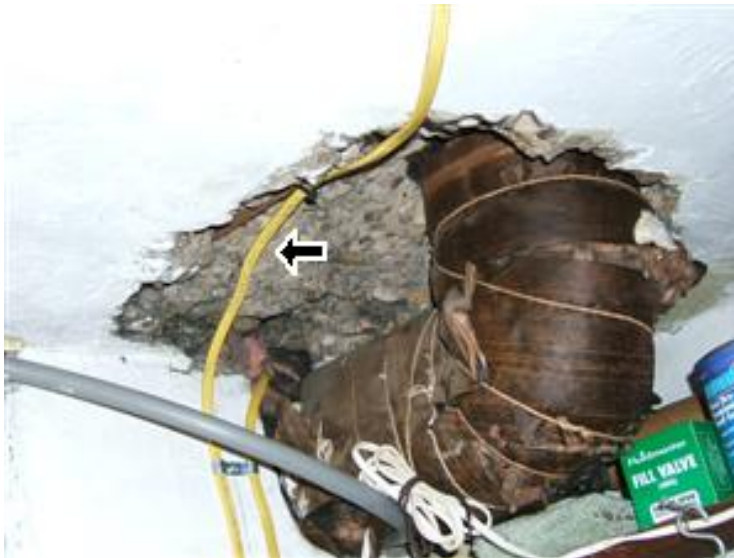
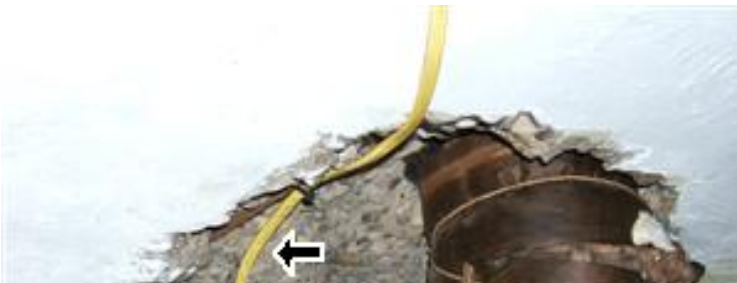
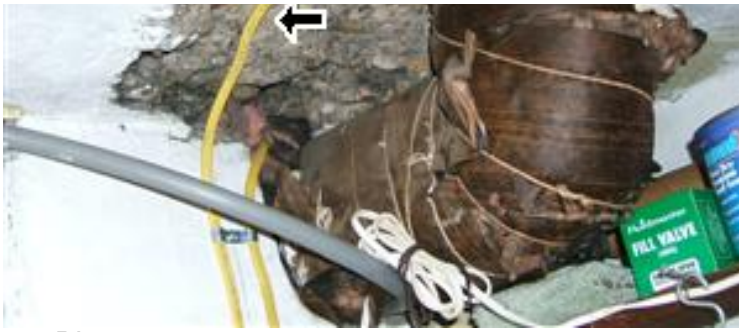
4.5 WALLS / CEILINGS Picture 1

Concrete ceiling noted (slab of the addition), missing materials noted at the front corner that were removed for the heating duct. Repair as desired.

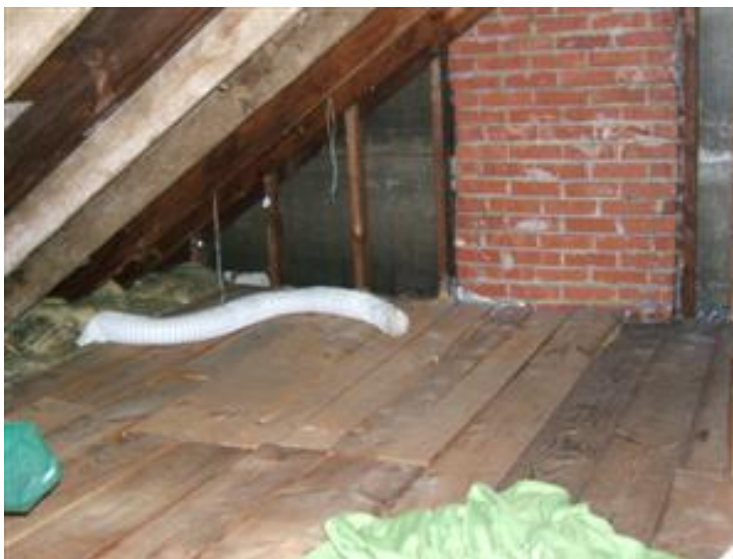
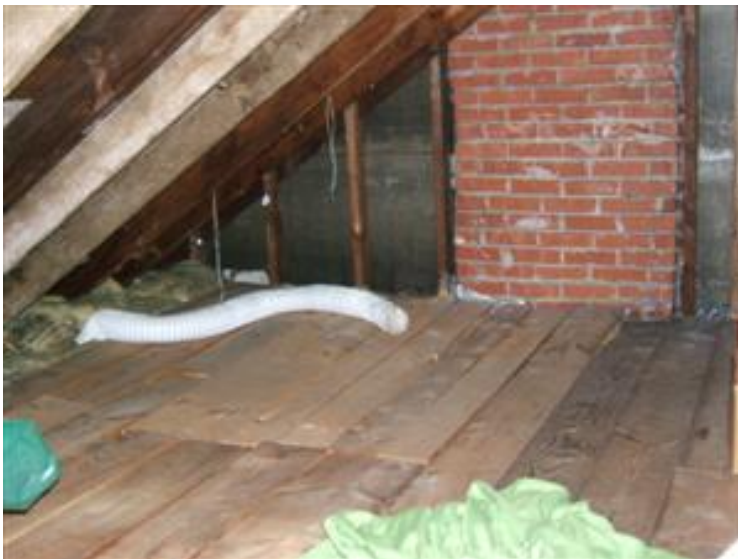
5.2 VENTILATION PROVISIONS Picture 1

Exhaust vent from bathrooms vent directly to attic area, not recommended practice. May lead to mold growth. Recommend venting directly to the exterior as required.

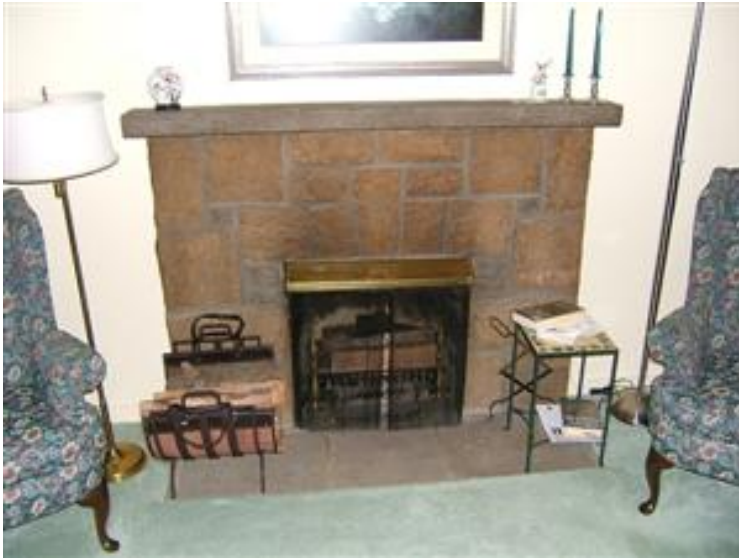
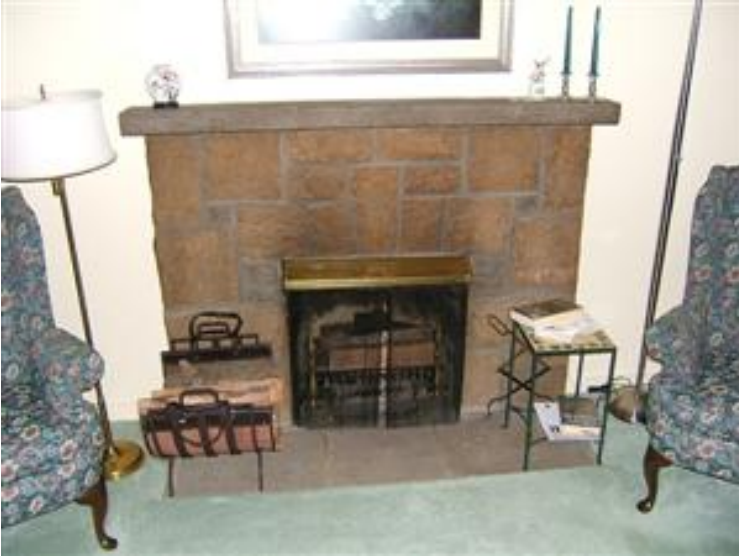
8.9 FIREPLACE(S) Picture 1

Visual inspection of firebox and damper area only, a standard home inspection does not include drafting or NFPA inspections on any level. Review supplemental information titled fireplace/chimneys. Loose firebrick noted; recommend repair or re-pointing by a qualified contractor. Review supplemental information titled firebox in Fireplace section. Substantial creosote buildup noted. No evaluation of interior components possible. Have unit cleaned and serviced prior to use. Mortar gaps or hollow bricks noted, Recommend proper sealing of these areas by a qualified contractor. If the hollow bricks are present in the throat or smoke chamber, it is required that the area be parge coated smooth. It appears the smoke chamber has been made smaller by the addition of some stone and firebrick.

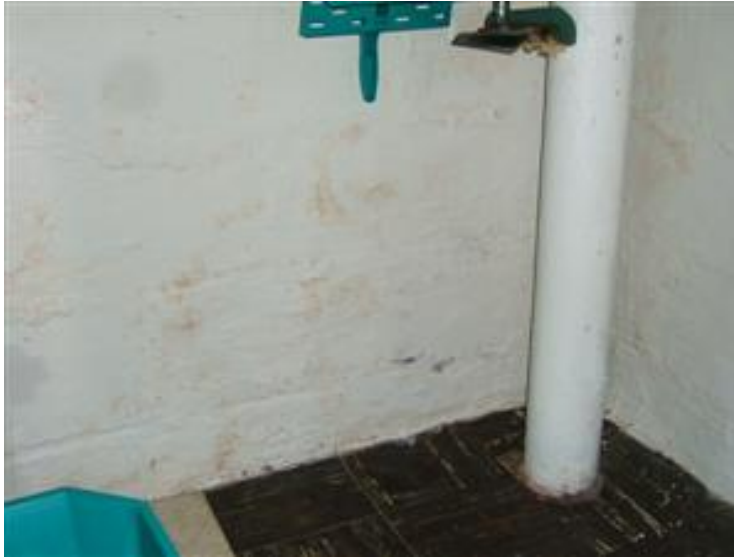
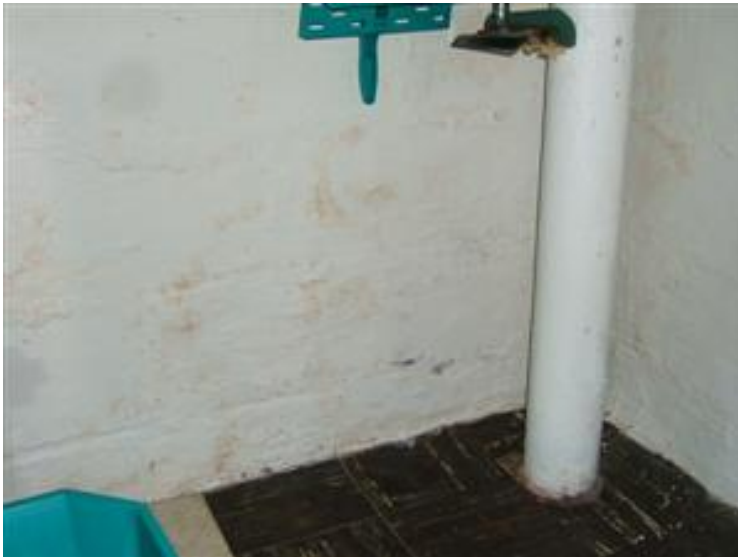
10.1 INTERIOR CONDITIONS Picture 1

Report comments are based on conditions observable at the time of inspection; it is not possible to accurately determine the extent of any past conditions or to predict future conditions or concerns. Water stains noted at basement; indicative of leakage from the exterior. Review comments in exterior and site grading sections of report and repair or replace elements as needed.

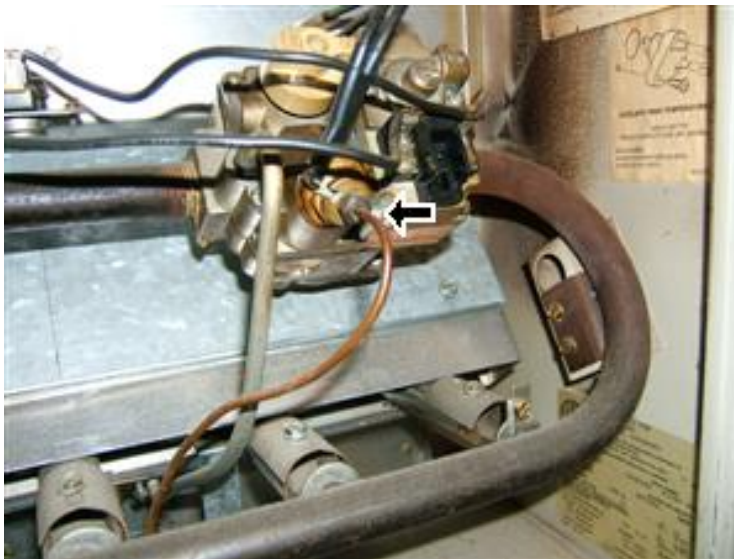
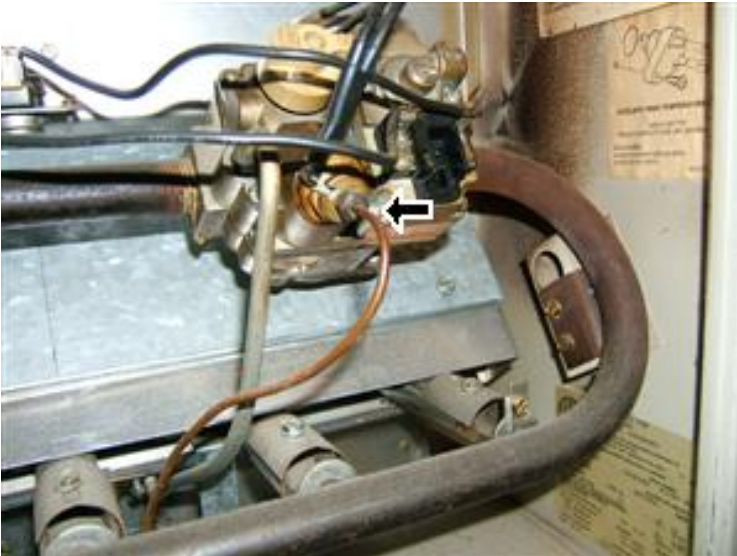
14.7 GAS PIPING Picture 1

Leakage detected at fitting at the furnace; repair as required.

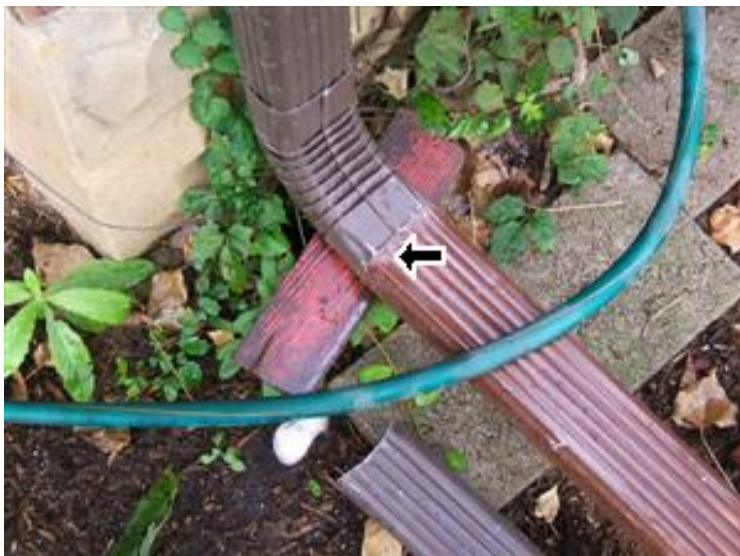
1.8 DOWNSPOUTS / ROOF DRAINS Picture 1

Leakage noted at front corner fitting; Repair as needed.

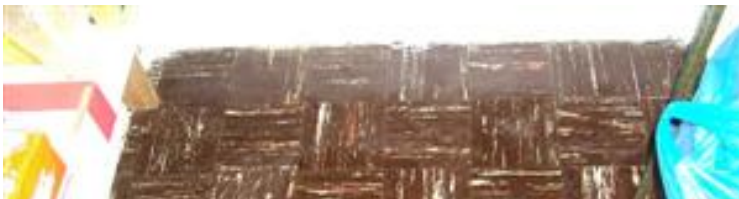
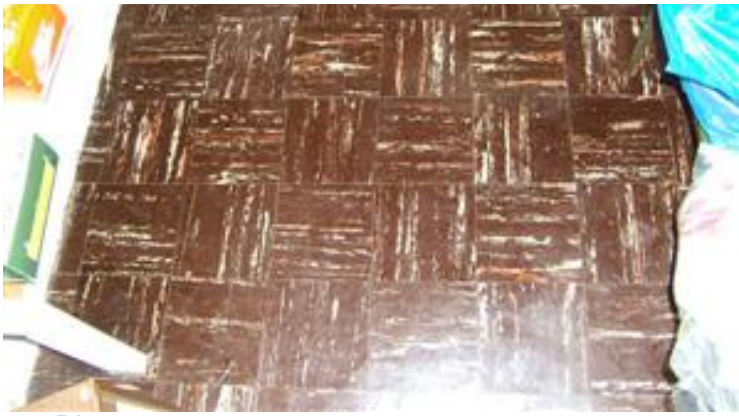
9.4 BASEMENT FLOOR (SLAB) Picture 1

Typical cracking noted. Monitor and correct as desired. Older 9"x9" floor tiles noted, Due to age it may be an asbestos containing product, Review supplemental information titled ACM insulation.

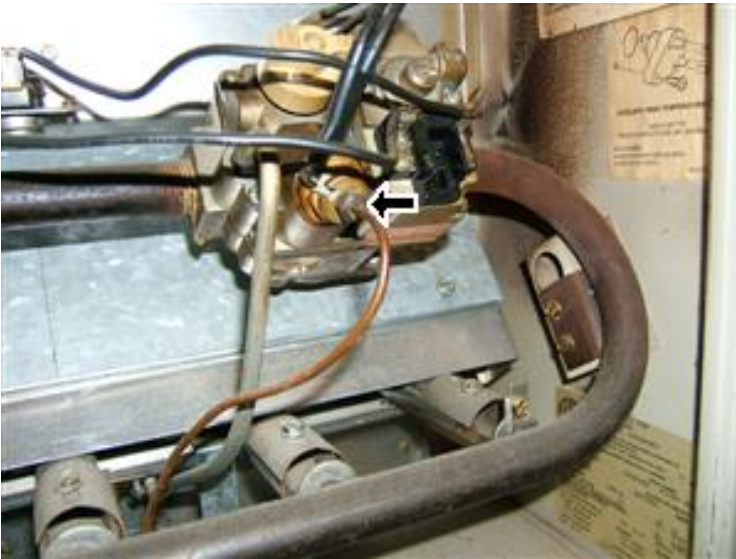
13.2 GAS / FUEL LINES AT UNIT Picture 1

Leak detected at the control box ; Recommend repair by a qualified contractor.

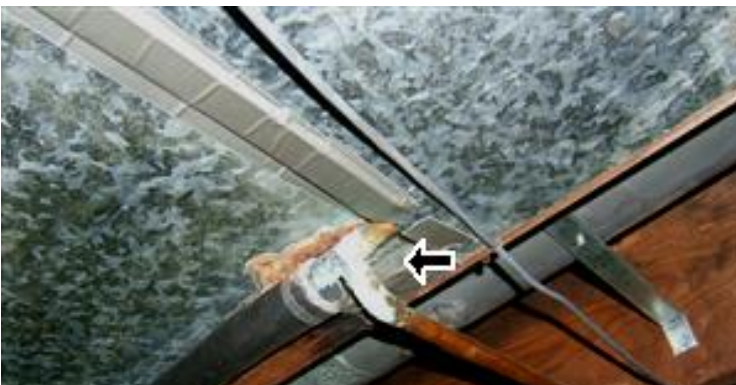
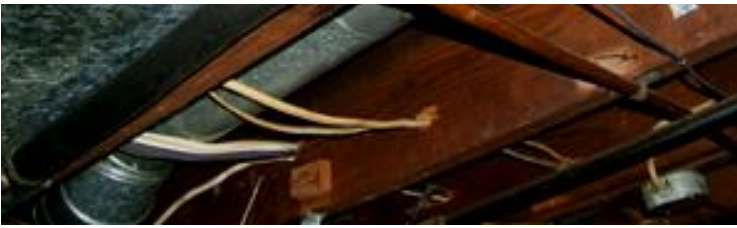
14.0 WATER PIPING Picture 1

Corrosion noted at joints and valves, Repair as needed Galvanic action noted at water line that is touching the return air ductwork (opposing metal) recommend repair or replacement of damaged pipes. Incoming line was possibly lead (limited visibility due to painting of line and walls, Monitor and correct as future conditions warrant. Many missing shut off valve handles, Replace as needed.
