Residential Building Inspection Report

AnyStreet Drive, Pittsburgh, PA 15237

Inspection Date:
02/28/2019

Report Number:
0228190205JB

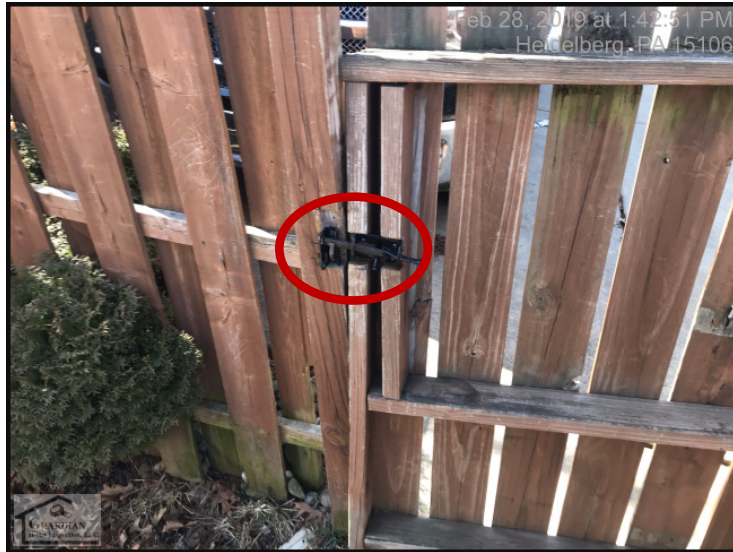
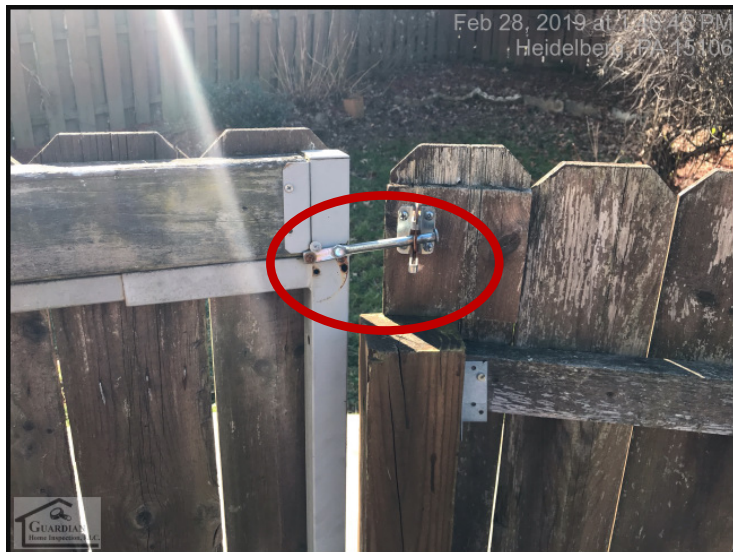
Figure 1 The gate and latch hardware on the fence is in poor operating condition.

Figure 2 The gate and latch hardware on the fence is in poor operating condition.

- **General Repair Item:** The gate and latch hardware on the fence is in poor operating condition. A qualified fencing contractor can perform repairs.

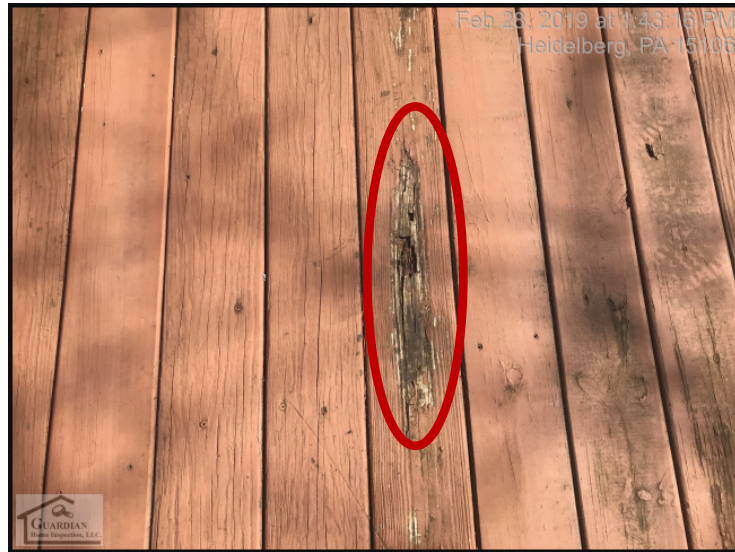
- **General Repair Item:** Several of the wood planks, on the exterior decking, exhibit signs of moisture related rot. Replacement of the damaged planking is recommended. A qualified decking contractor can perform repairs.

Figure 3 Several of the wood planks, on the exterior decking, exhibit signs of moisture related rot.

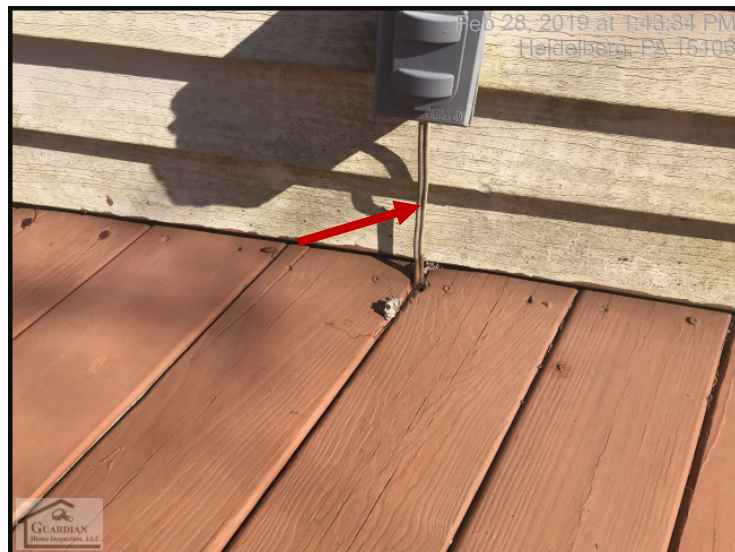
- **General Repair Item:** The electrical branch wiring, servicing the exterior electrical outlets, is not rated for outdoor use. Outdoor electrical wiring should be protected by a conduit or Type UF cable (Type UF is covered by heavy plastic sheathing). If left uncorrected, this condition will result in premature deterioration of the exposed wiring. A qualified electrician can provide repair.

Figure 4 The electrical branch wiring, servicing the exterior electrical outlets, is not rated for outdoor use.

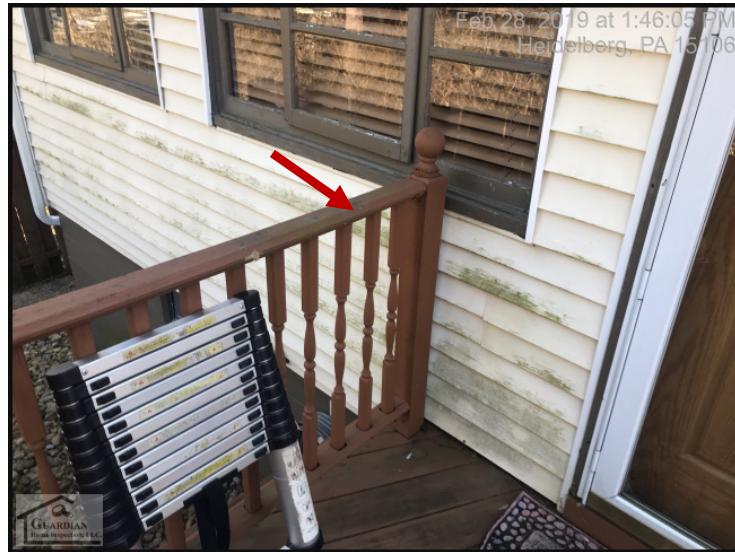
- **General Repair Item:** The wood guard railing, on the deck, is significantly loose (next to entry door) and should be adequately resecured (see photo). A qualified decking contractor can perform repairs.

Figure 5 The wood guard railing, on the deck, is significantly loose (next to entry door) and should be adequately resecured.

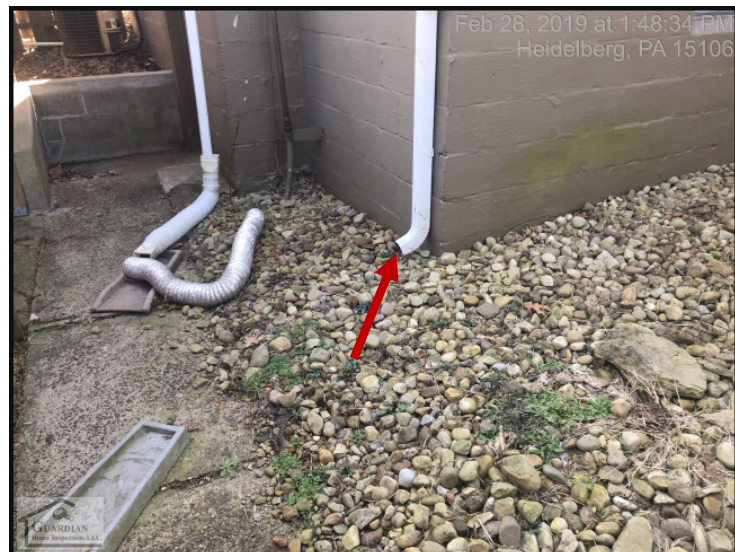
- **General Repair Item:** The gutter downspout, at the northeast exterior corner of the home, should discharge further away from the foundation. Downspouts should discharge water at least five (5) feet from the house, where possible. Storm water should be encouraged to flow away from the building at the point of discharge to help prevent water infiltration from occurring along the interior foundation.

Figure 6 The gutter downspout, at the northeast exterior corner of the home, should discharge further away from the foundation.

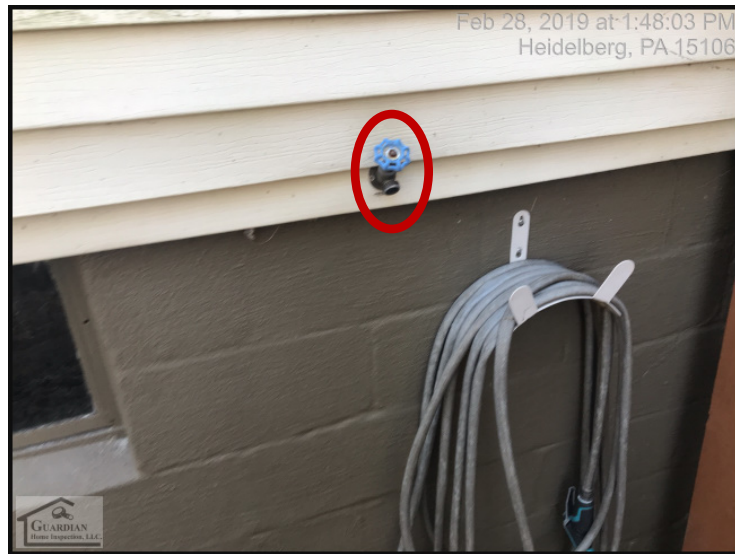
Figure 7 The exterior hose faucet lacks and anti-siphon device.

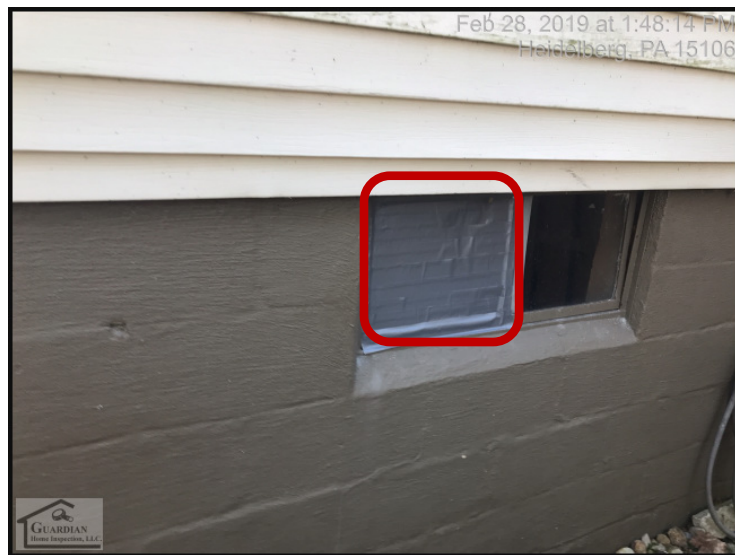
Figure 8 A window pane, along the north facing basement wall, is damaged and requires replacement.

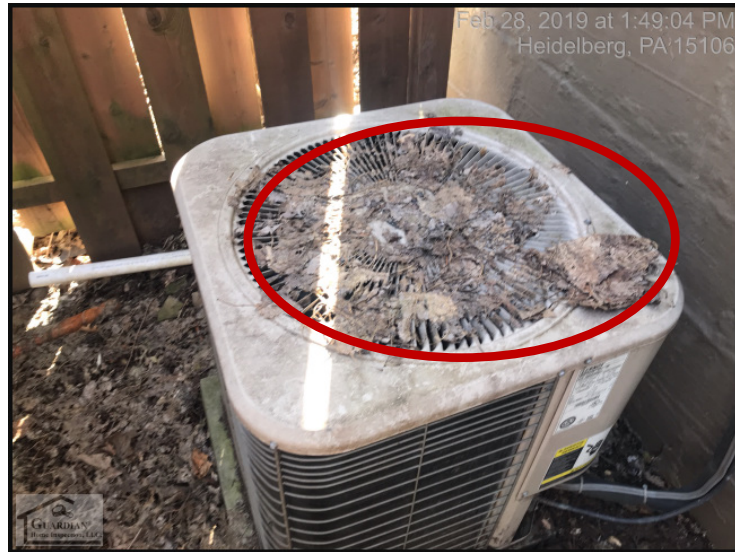
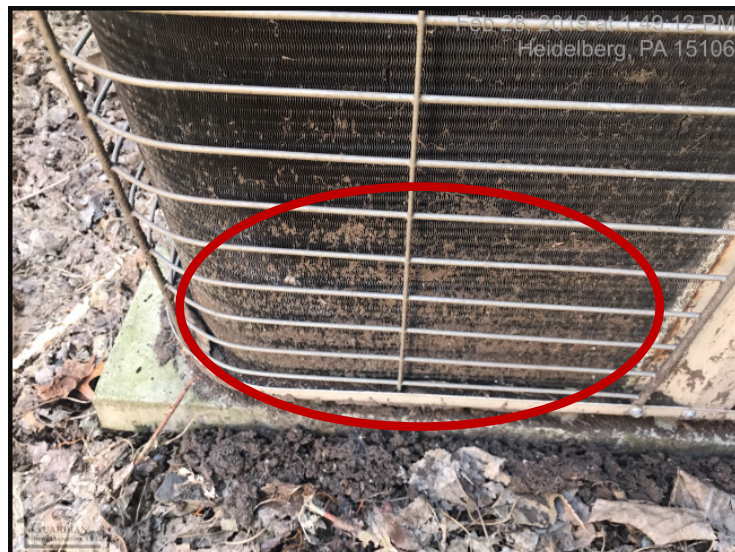
Figure 9 The condensing coil fins, on the exterior AC unit, are significantly dirty.

Figure 10 The condensing coil fins, on the exterior AC unit, are significantly dirty.

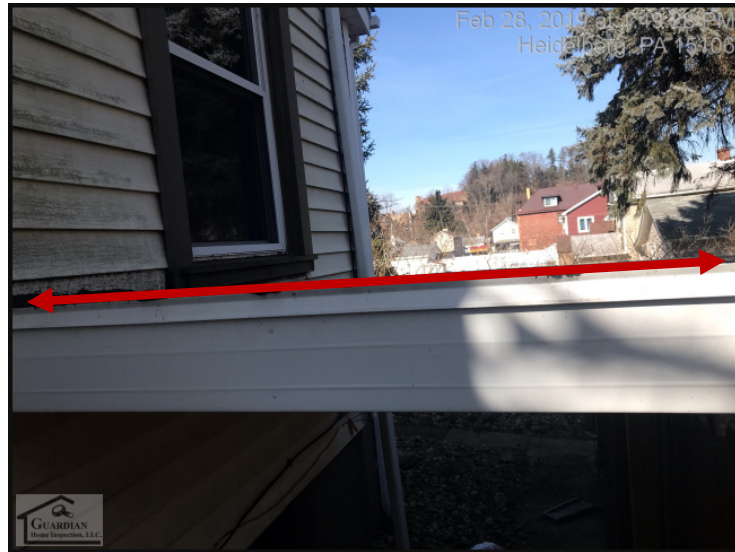
- **General Repair Item:** The asphalt composition shingles, on the east facing roof overhang, were installed on a roof with a slope of less than 2 inches of rise within 12 inches of horizontal run. Generally accepted current standards require that the underlying roofing felt, under the shingles, be doubled when asphalt composition shingles are installed on a roof with a slope of less than 2/12. If left uncorrected, this condition will be prone to leakage. A qualified roofer can provide repair.

Figure 11 The asphalt composition shingles, on the east facing roof overhang, were installed on a roof with a slope of less than 2 inches of rise within 12 inches of horizontal run.

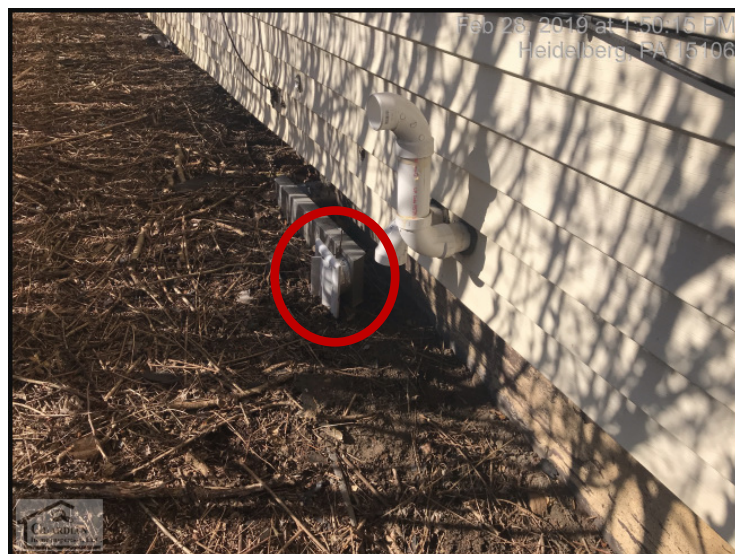
- **General Repair Item:** The dryer exhaust vent is discharging at ground level. This condition may result in a blocked dryer exhaust pipe which prevents moist air from adequately venting to the exterior and may also create a potential fire hazard due to dryer lint accumulation.

Figure 12 The dryer exhaust vent is discharging at ground level.

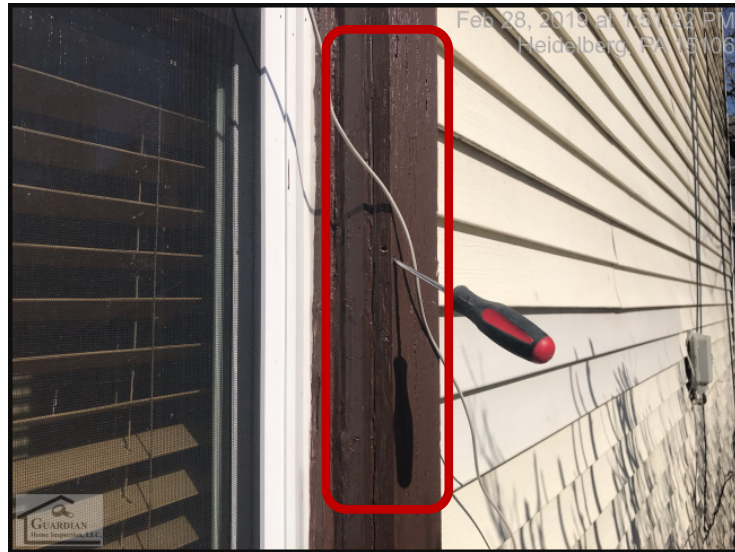
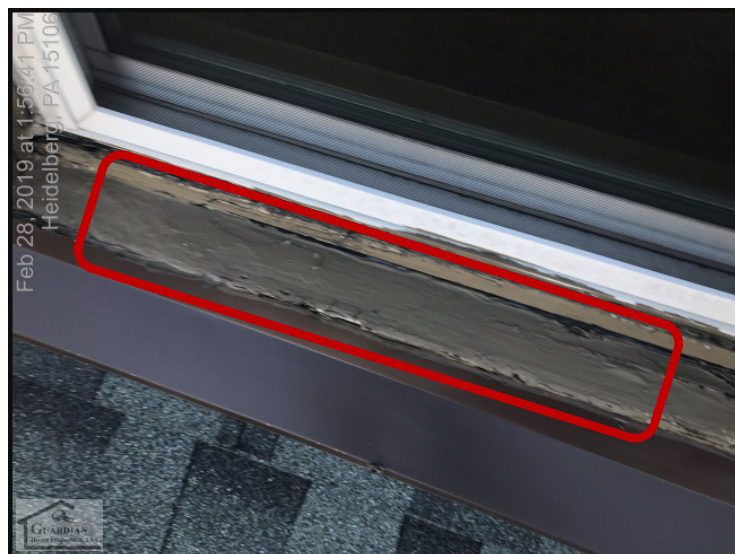
- **Major Repair Item:** Most of the exterior wood window trim, framing and sills are significantly moisture rotted and should be replaced, painted and caulked. You should consult with a qualified carpenter to discuss options and approximate costs for replacement. Maintaining the window and door exteriors on an annual basis will extend their lifespan.

Figure 13 Most of the exterior wood window trim, framing and sills are significantly moisture rotted and should be replaced, painted and caulked.

Figure 14 Most of the exterior wood window trim, framing and sills are significantly moisture rotted and should be replaced, painted and caulked.

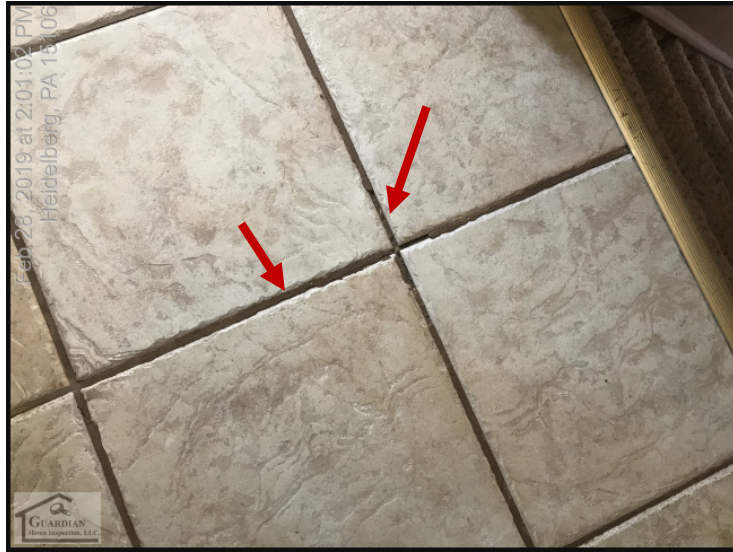
- **General Repair Item:** Some areas of missing grout were observed along the floor tiles in the 2nd floor hallway. You should consult with a qualified flooring contractor for repairs.

Figure 15 Some areas of missing grout were observed along the floor tiles in the 2nd floor hallway.

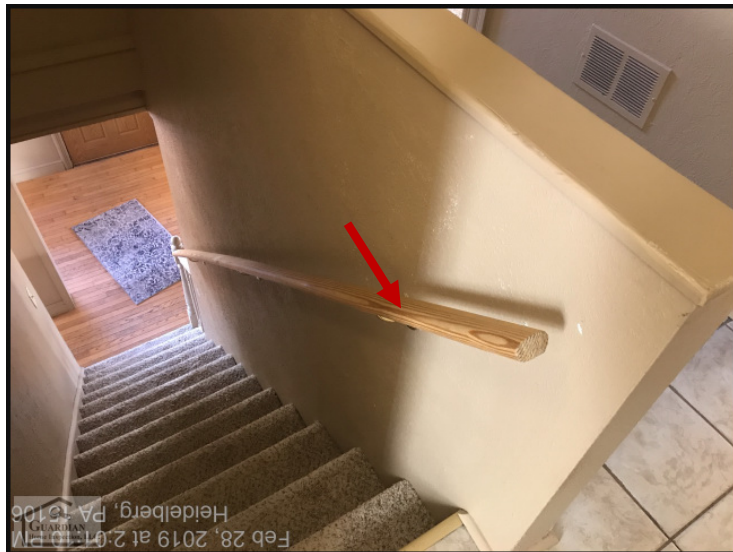
- **General Repair Item:** The handrail, on the first-floor stairway, is loose/unsecured; repair is recommended.

Figure 16 The handrail, on the first-floor stairway, is loose/unsecured; repair is recommended.

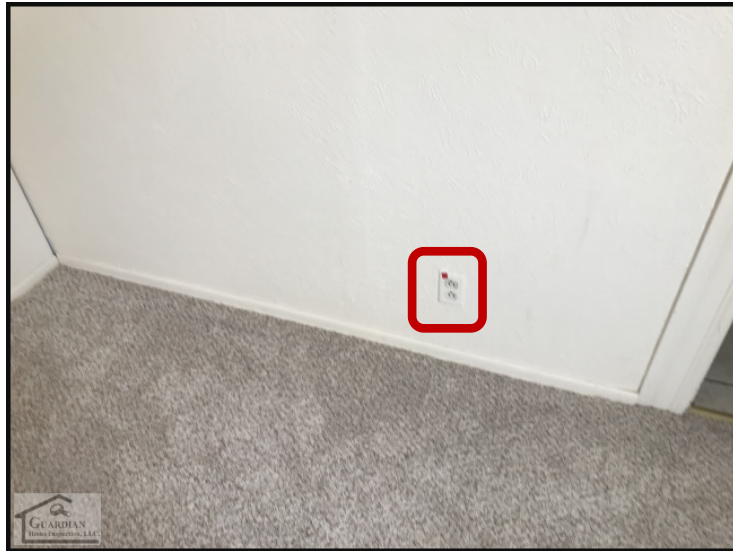
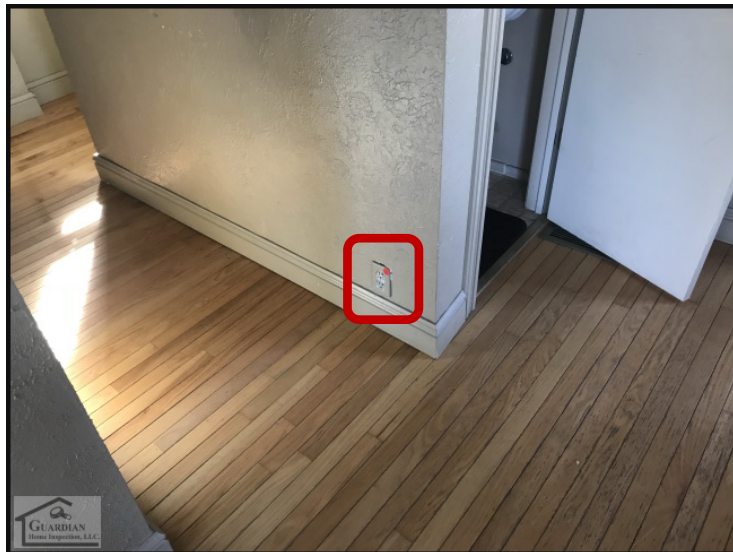
- **Safety Related Repair Item:** Several of the three-prong electrical outlets, in the home, are ungrounded and have been labeled with red stickers. The third prong on an outlet is commonly referred to as 'the ground', and it provides an alternate path for electricity that may stray from an appliance or product. Without this protection, your risk of electrical shock is greater and surge protectors cannot protect your electrical equipment, such as televisions, computers, stereos, and other devices. This condition should be repaired by a qualified electrician.

Figure 17 Several of the three-prong electrical outlets, in the home, are ungrounded and have been labeled with red stickers.

Figure 42 Several of the three-prong electrical outlets, in the home, are ungrounded and have been labeled with red stickers.

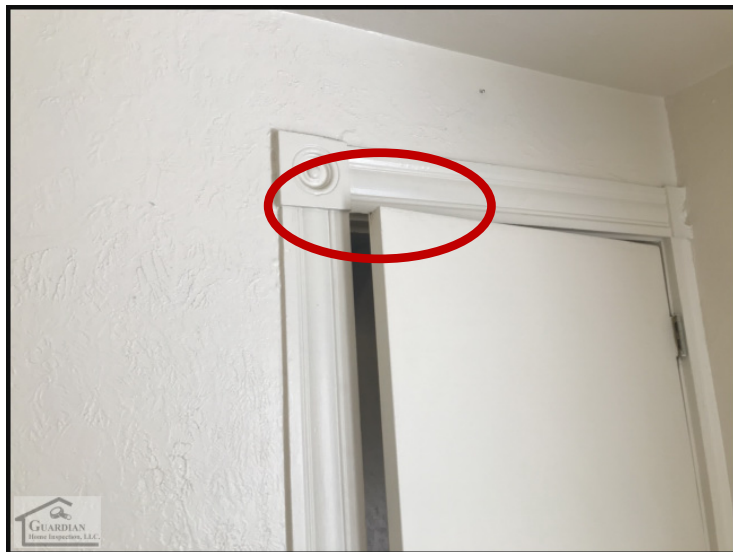
Figure 18 The 2nd floor west facing bedroom door does not open/close smoothly and should be trimmed or adjusted as necessary.

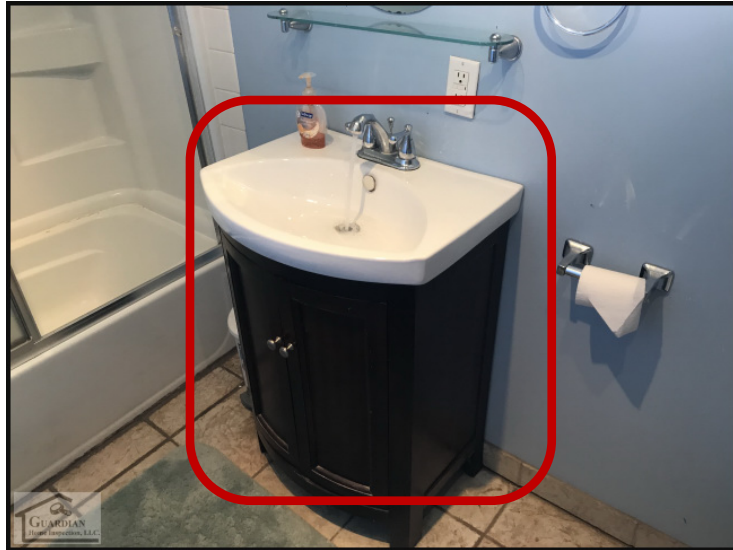
Figure 19 The second-floor hallway bathroom sink and cabinet are not well secured to the adjacent wall.

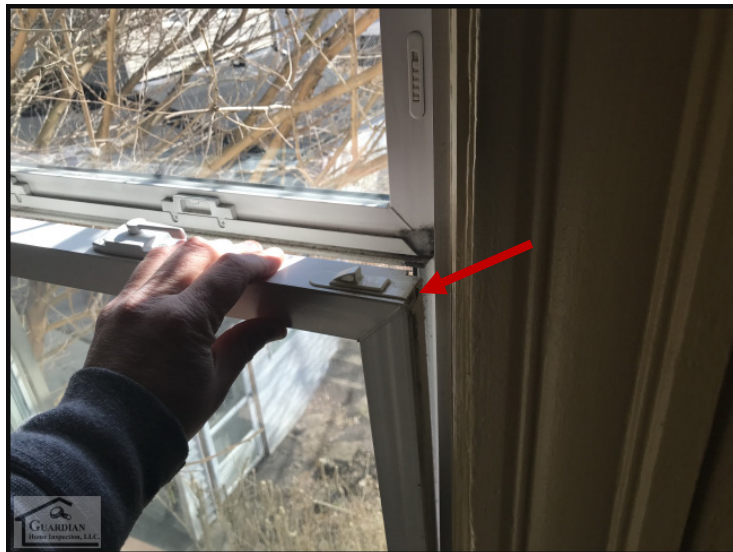
Figure 20 The tilt latches, on the 2nd floor southeast facing bedroom window, are broken.

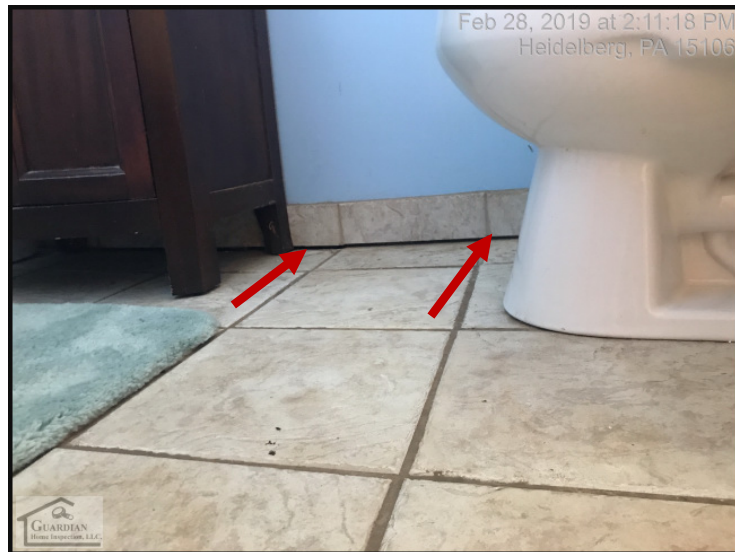
- **General Repair Item:** The wall tile, in the 2nd floor bathroom, has separated from the floor tile against the north facing wall (see photo). This condition may be the result of a poor installation or the result of some underlying settlement or sagging of the underlying floor framing. A qualified floor tile specialist can provide repair.

Figure 21 The wall tile, in the 2nd floor bathroom, has separated from the floor tile against the north facing wall

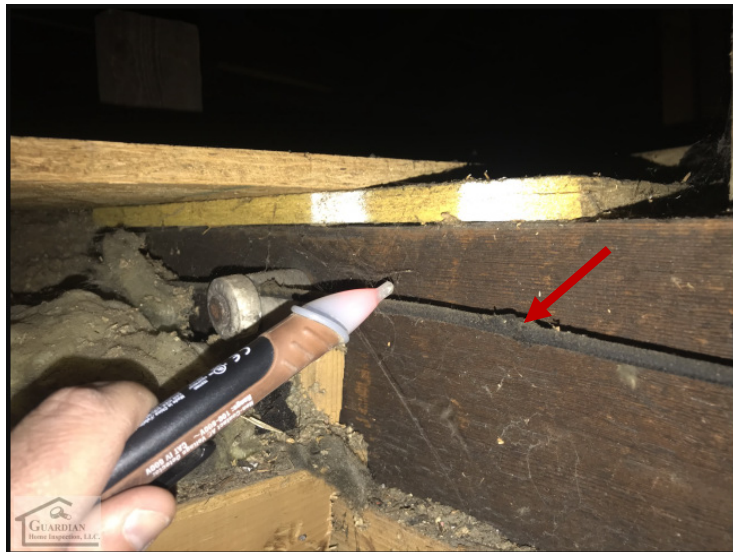
- **Investigate:** Active knob & tube wiring was observed within the attic space. Knob-and-tube wiring was an early standardized method of electrical wiring in buildings, in common use in North America from about 1880 to the 1940s. The system is now considered obsolete and can be a safety hazard, although some of the fear associated with it is undeserved. All visible knob & tube wiring appeared to be in satisfactory physical condition; however, you may wish to have the condition of the non-visible knob & tube wiring evaluated further by a qualified electrician.

Figure 22 Active knob & tube wiring was observed within the attic space.

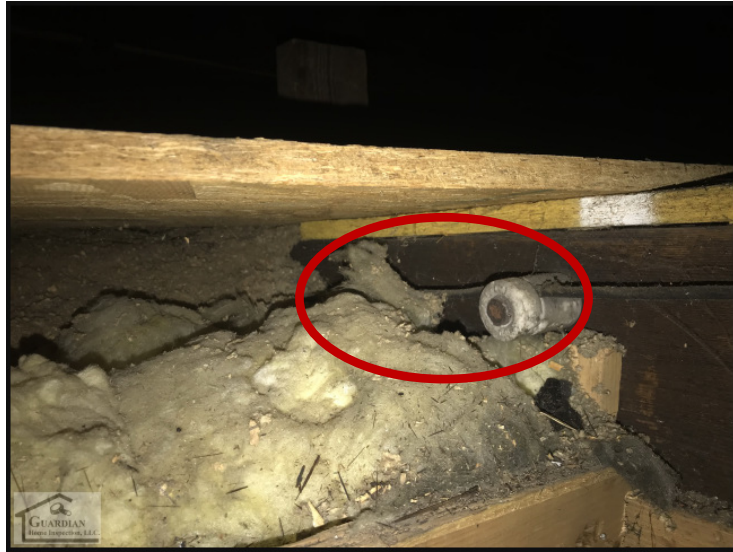
- **General Repair Item:** Active knob & tube wiring was observed in the attic covered with insulation. Knob and tube wiring will dissipate heat and covering the wiring with insulation is not recommended. Active knob & tube wiring should not be within 6" of insulation. Consult a qualified electrician for further evaluation and repair.

Figure 23 Active knob & tube wiring was observed in the attic covered with insulation.

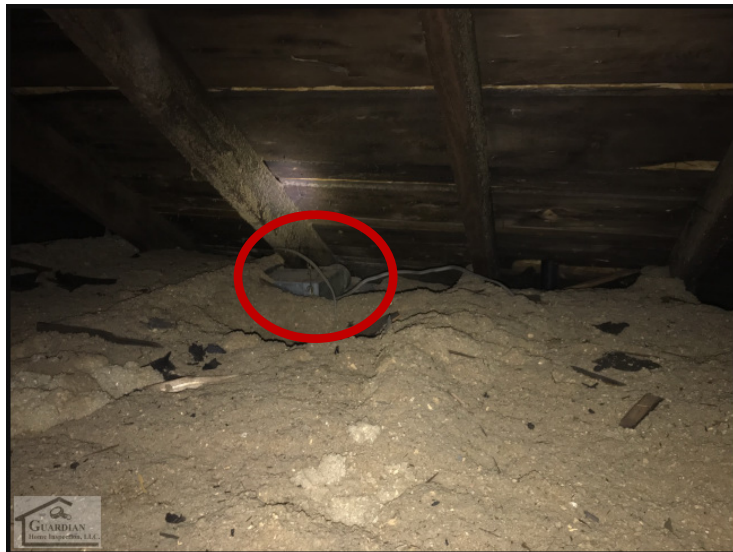
- **General Repair Item:** The bathroom exhaust fan is exhausting into the attic. This condition, if left uncorrected, may create unnecessary moisture accumulation, mildew, and possible mold conditions in the attic space. All exhaust vent pipes should be insulated and vented to the building exterior through the roof or immediately adjacent to any roofing ventilation (gable, ridge, roof vents).

Figure 24 The bathroom exhaust fan is exhausting into the attic.

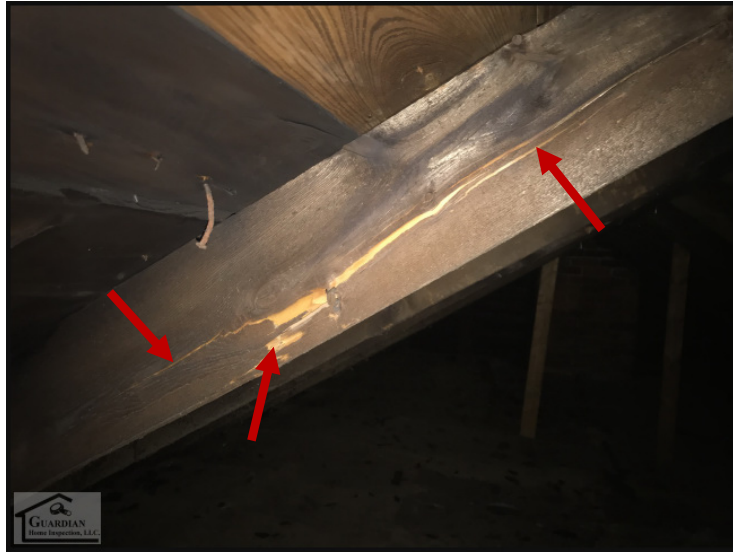
- **General Repair Item:** A wooden roof rafter, along the south facing slope of the attic, has cracked the extent of its depth. The rafter should be reinforced or replaced to reinstate the original structural integrity. If left uncorrected, this condition may result in sagging of the overhead roof plane. Consult a qualified carpenter for further evaluation and repair options.

Figure 25 A wooden roof rafter, along the south facing slope of the attic, has cracked the extent of its depth.

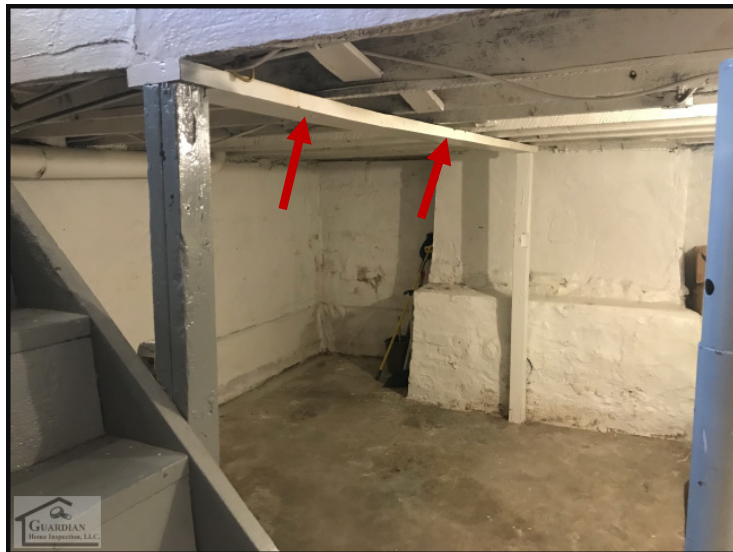
Figure 26 The floor framing, along the basement ceiling, has been reinforced in several locations with central support framing.

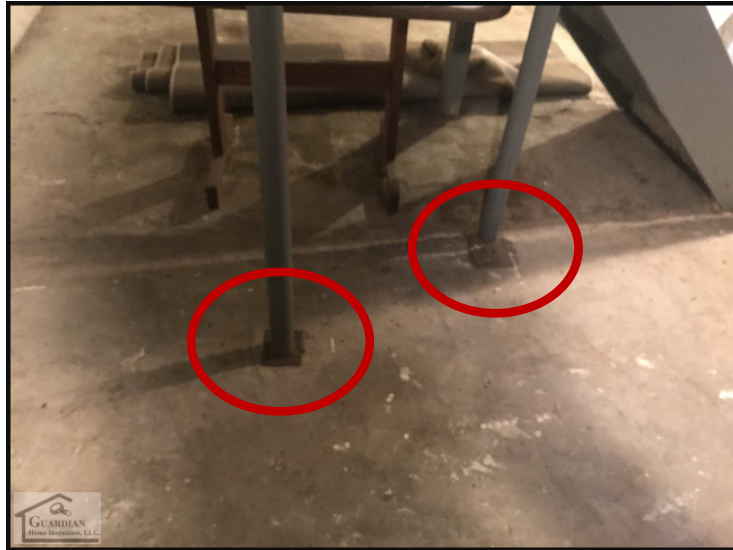
Figure 27 The reinforcing vertical support posts do not appear to have underlying concrete footers installed.

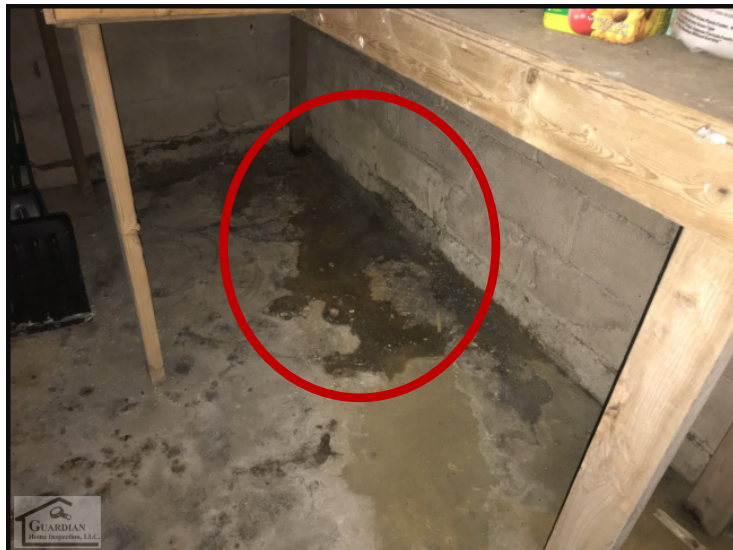
- **General Repair Item:** The interior north facing basement foundation wall exhibited evidence of moisture infiltration and staining/efflorescence. This condition indicates that moisture has accumulated in that area in the past; however, the severity or frequency could not be determined during a one-time inspection of the home. The vast majority of basement leakage problems are the result of insufficient control of storm water along the exterior of the home. As a first step in eliminating any future moisture infiltration; gutters should be cleaned and the underground downspouts snaked thoroughly to check for blockage and/or leakage. In addition, the use of a dehumidifier would also be wise. You should also review the sellers' disclosure and consult with the sellers in regard to the severity and/or frequency of moisture infiltration in the basement during periods of extended rainfall.

Figure 28 The interior north facing basement foundation wall exhibited evidence of moisture infiltration and staining/efflorescence.

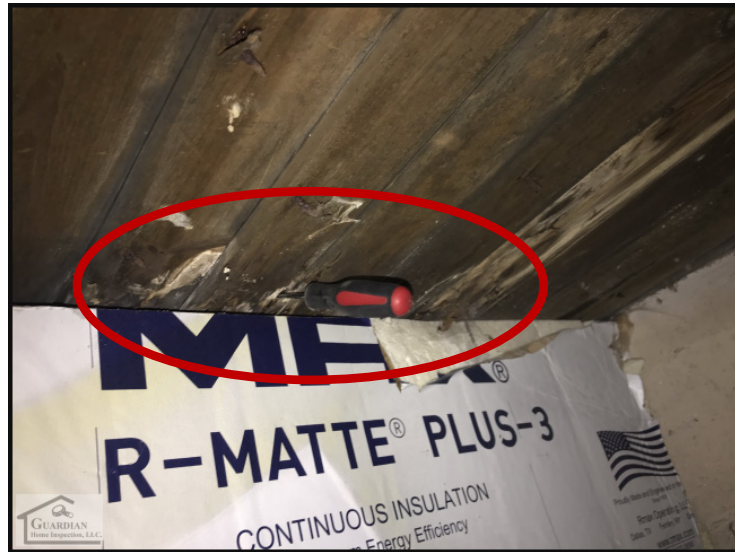
Figure 29 An area of the sub-flooring, along the basement ceiling (below the north facing entry door), exhibits evidence of moisture related rot.

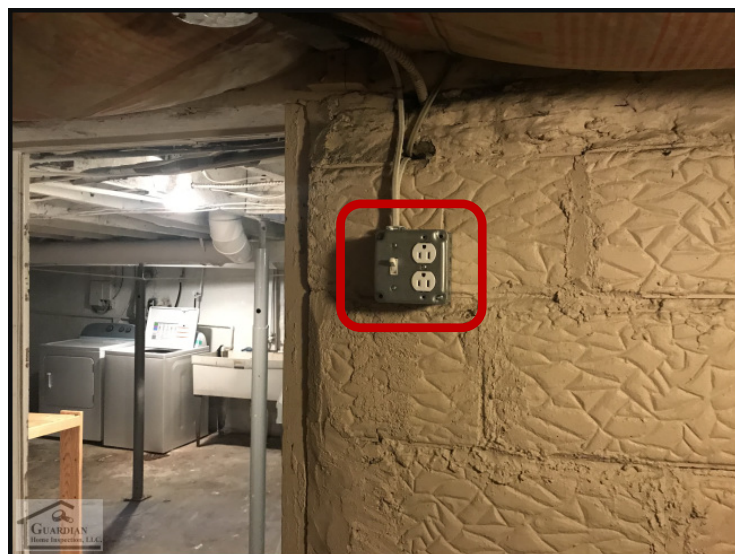
- **Safety Related Repair Item:** The home lacks *adequate* Ground Fault Circuit Interrupter (GFCI) outlet protection in the powder room, along the exterior walls, in the unfinished basement, and within 6 feet of the laundry sink. Although GFCI protection may not have been required at certain locations at the time the home was built, for safety reasons, you should consider upgrading the electrical system to include GFCI protection where it is now required. This condition should be repaired by a qualified electrician.

Figure 30 The home lacks adequate Ground Fault Circuit Interrupter (GFCI) outlet protection in the unfinished basement.

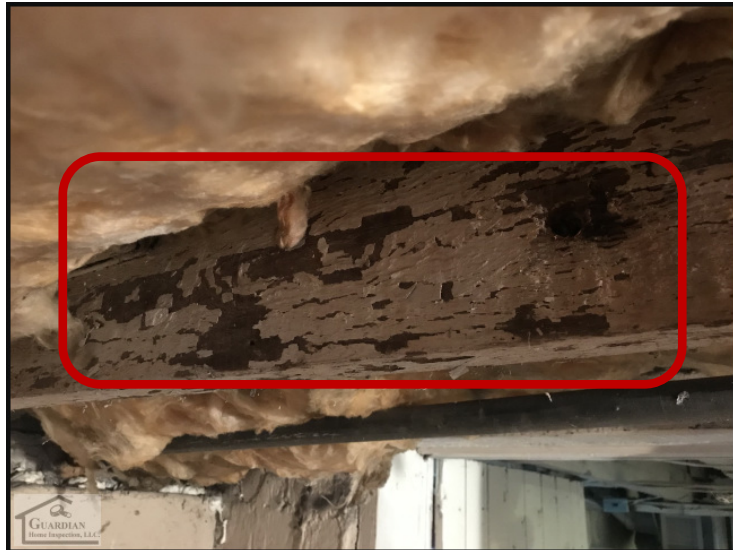
Figure 31 Based on the age of this home, there is a possibility the peeling paint, on the floor joists along the basement ceiling, may contain some lead based paint.

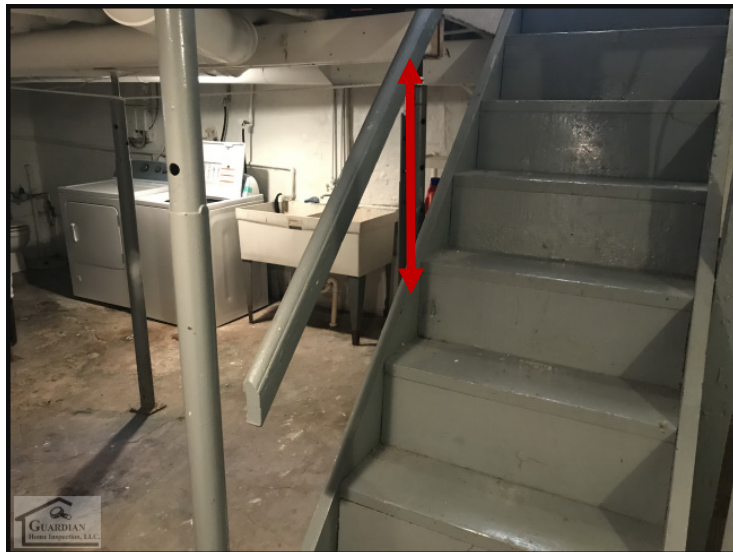
- **Safety Related Repair Item:** As there is a danger of falling, a step railing should be provided along at least one side of the basement stairway. Open sides of stairs with a total rise of more than 30 inches above the floor or grade below shall have guards not less than 34 inches in height measured vertically from the nosing of the treads with balusters no greater than 4" apart on center. This condition may be hazardous to small children.

Figure 32 As there is a danger of falling, a step railing should be provided along at least one side of the basement stairway.

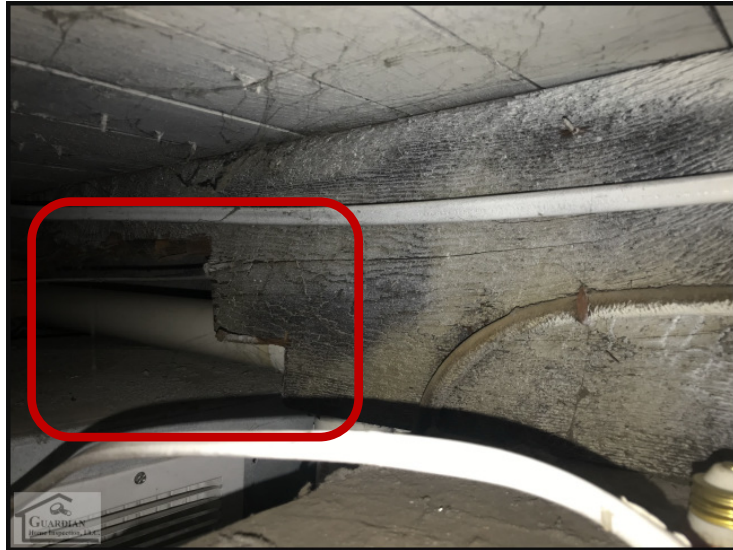
- **General Repair Item:** A wooden floor joist, along the basement ceiling (above the furnace) has been excessively notched (see photo). Maximum notch depth should not exceed 1/6 of the joist depth. This condition reduces the overall structural strength of the floor joist. Reinforcement of the affected floor joist is recommended. Consult a qualified carpenter for repairs.
- **General Repair Item:** An area of the sub-flooring, along the basement ceiling (below the north facing entry door), exhibits evidence of moisture related rot. The damaged materials should be replaced by a qualified carpenter.

Figure 33 A wooden floor joist, along the basement ceiling (above the furnace) has been excessively notched.

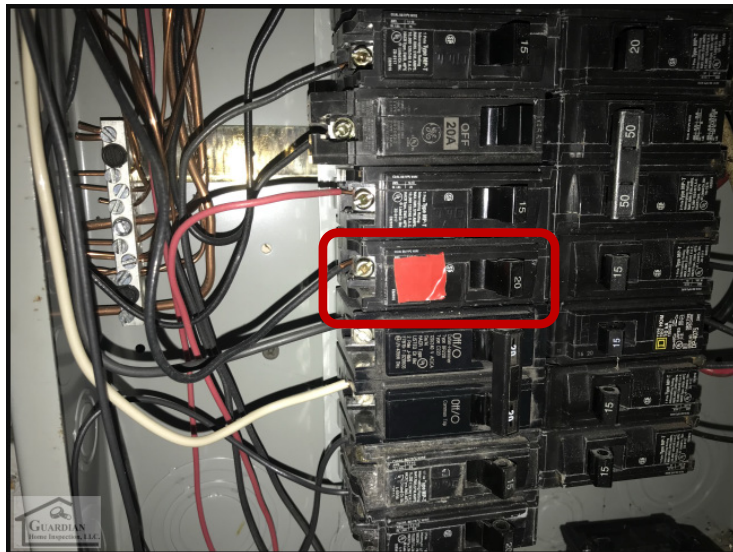
- **Safety Related Repair Item:** There is one oversized circuit breaker in the main electrical panel (20-amp breaker servicing 14-gauge wire - see photo). Oversized breakers have the potential to allow overheating to occur and create a fire hazard. The Inspector recommends this condition be corrected by a qualified electrician.

Figure 34 There is one oversized circuit breaker in the main electrical panel (20-amp breaker servicing 14-gauge wire).

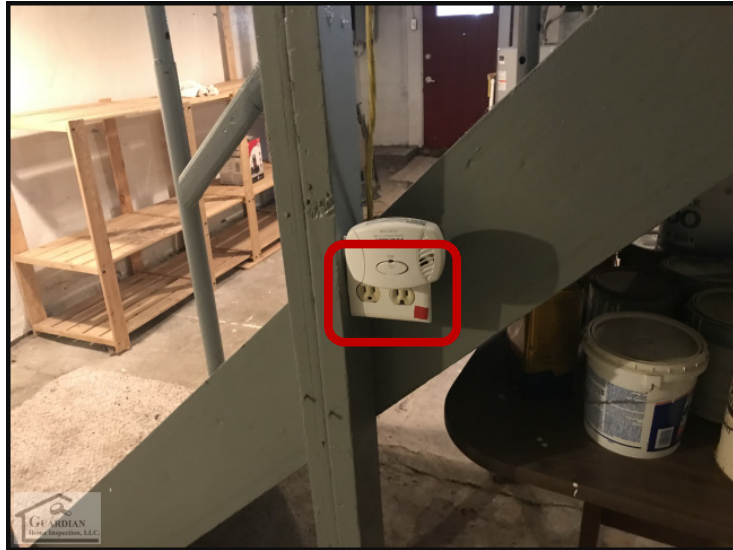
- **Safety Related Repair Item:** One three-prong electrical outlet, along the basement stairway, has reversed polarity (i.e. the hot and neutral wires are wired backwards). The outlet requiring repair has been labeled with a red sticker. Outlets near water with this problem are especially dangerous and could result in a shock hazard. This condition should be repaired by a qualified electrician.

Figure 35 One three-prong electrical outlet, along the basement stairway, has reversed polarity (i.e. the hot and neutral wires are wired backwards).

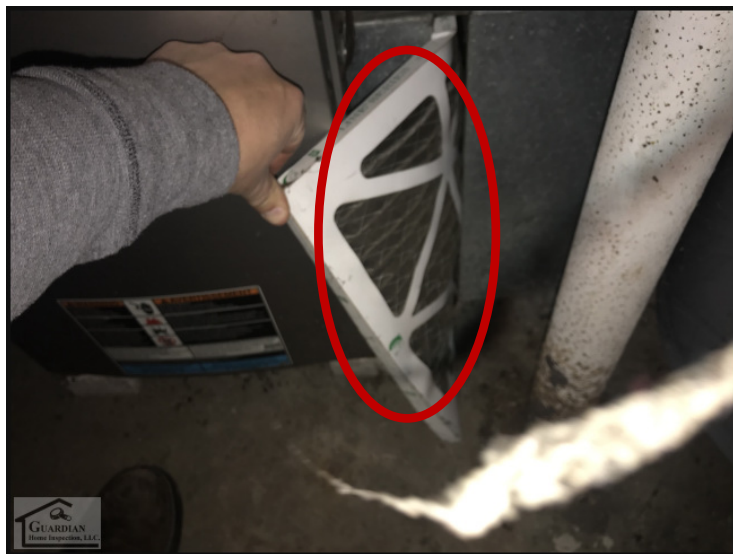
- **General Repair Item:** The dirty air filter, serving the furnace and air conditioner, should be replaced. A dirty filter will cause excessive strain on your furnace, air conditioner or heat pump. Check the air filter in your furnace or fan coil every 3 to 4 weeks and replace as necessary. The prefilter and collection cells of an electronic air cleaner should be cleaned at least two or three times per year.

Figure 36 The dirty air filter, serving the furnace and air conditioner, should be replaced.

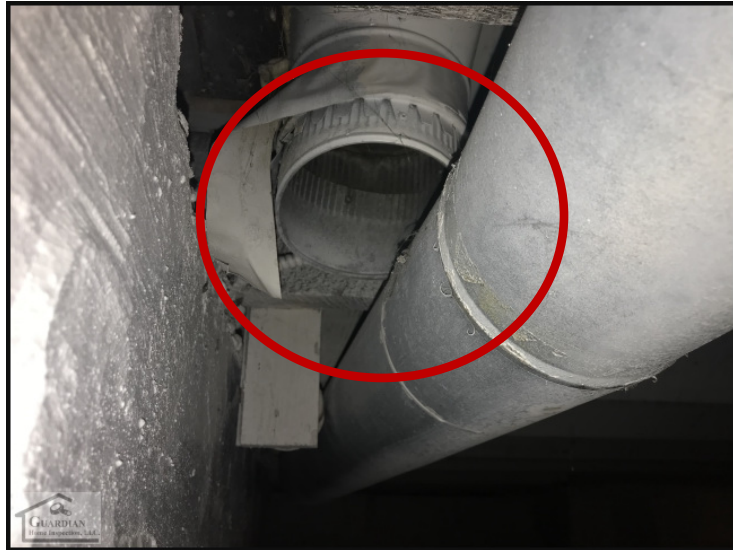
- **General Repair Item:** The disconnected supply ductwork, along the basement ceiling, should be reconnected to prevent air leakage and to improve overall balancing of the system.

Figure 37 The disconnected supply ductwork, along the basement ceiling, should be reconnected to prevent air leakage and to improve overall balancing of the system.

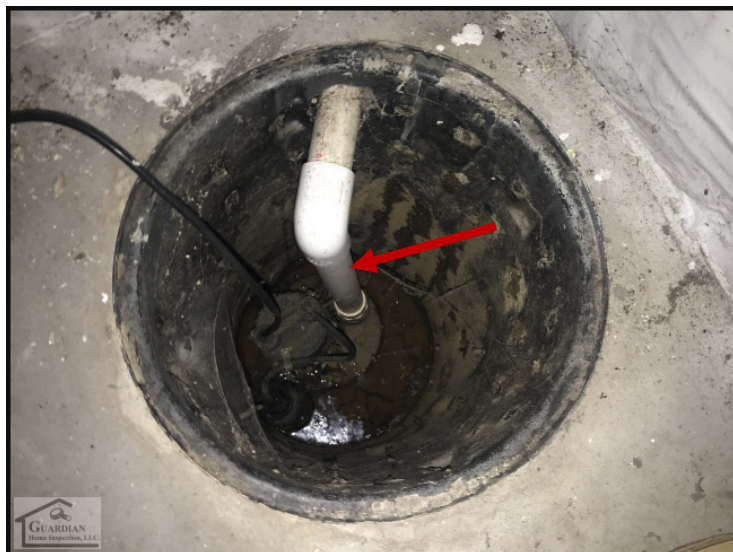
- **General Repair Item:** The sump pump has no visible check valves installed along its discharge piping. Check valves prevent water from spilling back into the sump pump well from the overhead discharge line. If left uncorrected, this condition may lead to over use (short cycling) of the sump pump leading to premature failure.

Figure 38 The sump pump has no visible check valves installed along its discharge piping.

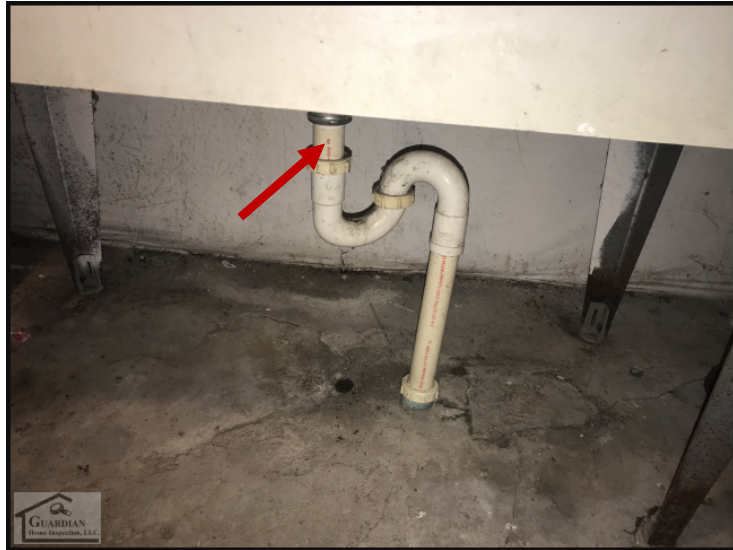
- **General Repair Item:** The drain piping, under the utility sink in the basement, was actively leaking at the time of inspection. The Inspector recommends correction by a qualified plumbing contractor.
- **General Repair Item:** The drain lines, under the kitchen sink, are double trapped. Only one P-trap per trap arm is permitted. To have two traps, you would need two trap arms, each one properly vented. This condition may result in drainage problems if air becomes trapped between the two traps as water drains. Consult a qualified plumber for further evaluation and repair options.

Figure 39 The drain piping, under the utility sink in the basement, was actively leaking at the time of inspection.

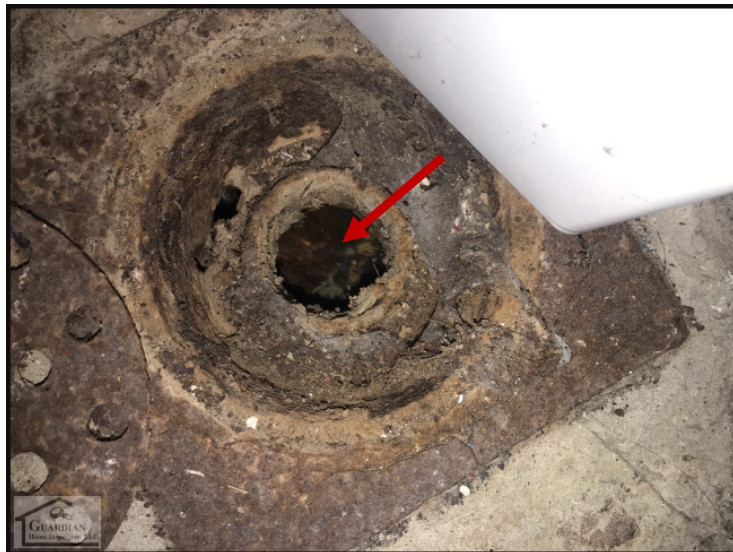
Figure 40 Because back-up or blockage in the drain lines sometimes takes extended periods of time to develop it is highly recommended that the overall inspection of the plumbing system includes a sewer cam inspection of the underground sewer lateral.

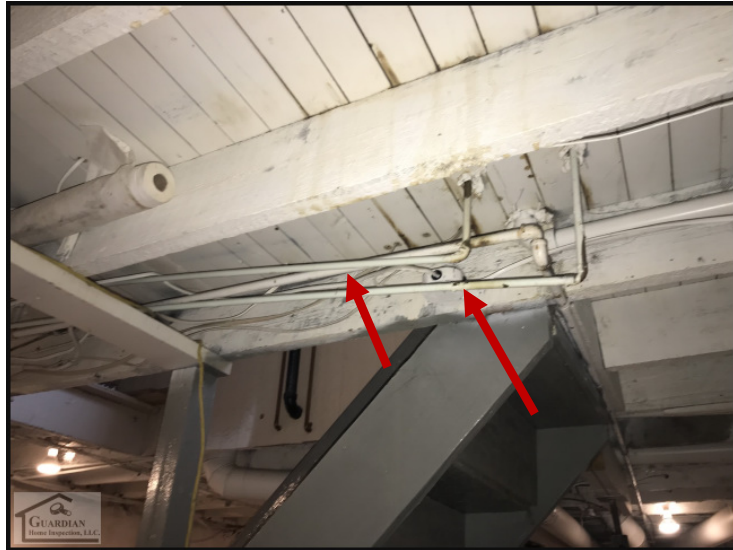
- **General Repair Item:** The water distribution piping, along the basement ceiling, is poorly supported in some areas. Generally-accepted current standards require that copper pipes of this diameter be supported a minimum of every 6 feet

and/or located at intervals so as to prevent sagging, damage and vibration. Well supported piping systems last longer and are quieter in use. The Inspector recommends correction by a qualified plumbing contractor.

Figure 41 The water distribution piping, along the basement ceiling, is poorly supported in some areas.

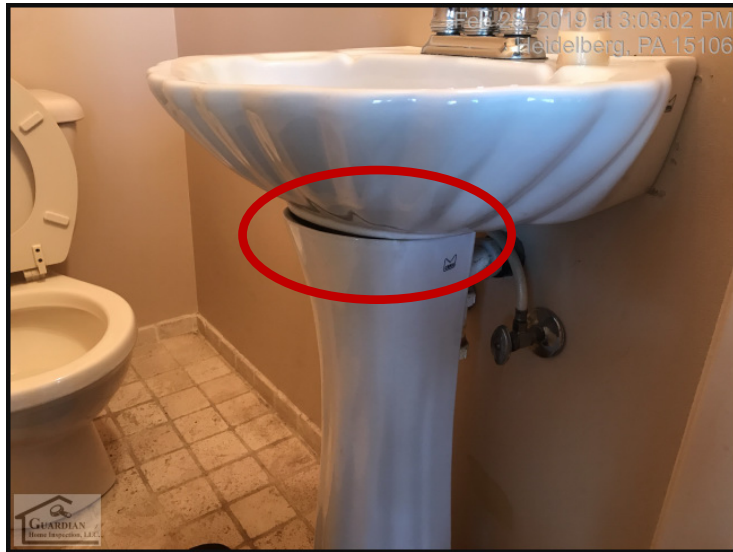
- **General Repair Item:** The pedestal sink, in the powder room, is not well seated into the underlying pedestal.
- **General Repair Item:** The second-floor hallway bathroom sink and cabinet are not well secured to the adjacent wall.
- **General Repair Item:** The toilet, in the powder room, is loose from the floor. A moderate tightening of the bolts will usually eliminate all movement; however, loose toilet fixtures often conceal leakage at the seal. If the subfloor is constructed of wood, moisture seepage at the seal can result in serious damage to wood members. To ensure against fungus and dry rot repairs, replacement of the wax seal and inspection of the connecting flange is recommended when repairing loose toilets.

Figure 43 The pedestal sink, in the powder room, is not well seated into the underlying pedestal.

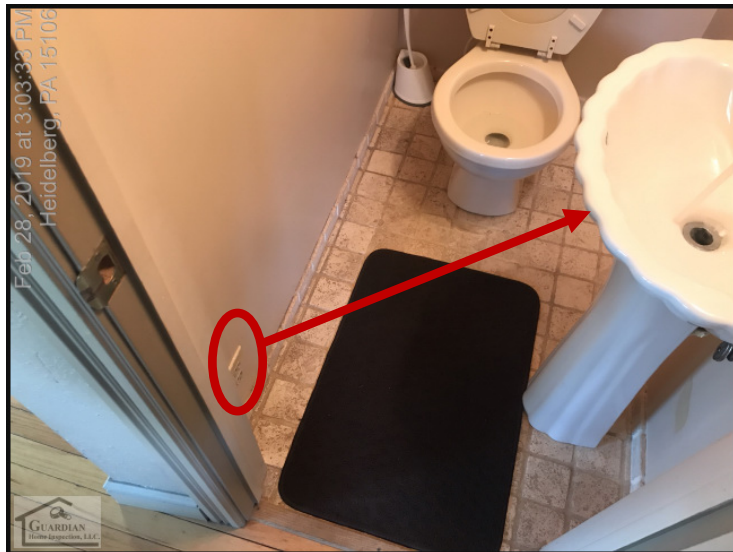
Figure 44 The home lacks adequate Ground Fault Circuit Interrupter (GFCI) outlet protection in the powder room.

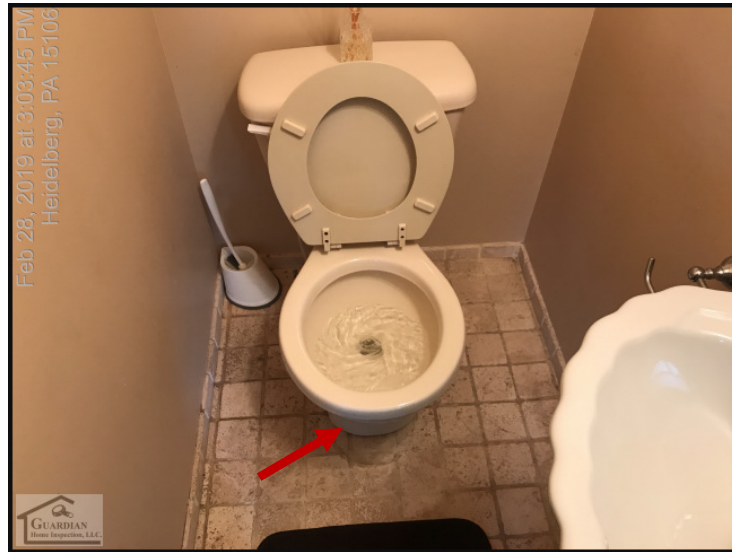
Figure 45 The toilet, in the powder room, is loose from the floor.
