Residential Building Inspection Report

AnyStreet Drive, Pittsburgh, PA 15237

Inspection Date:
02/28/2019

Report Number:
0228190205JB

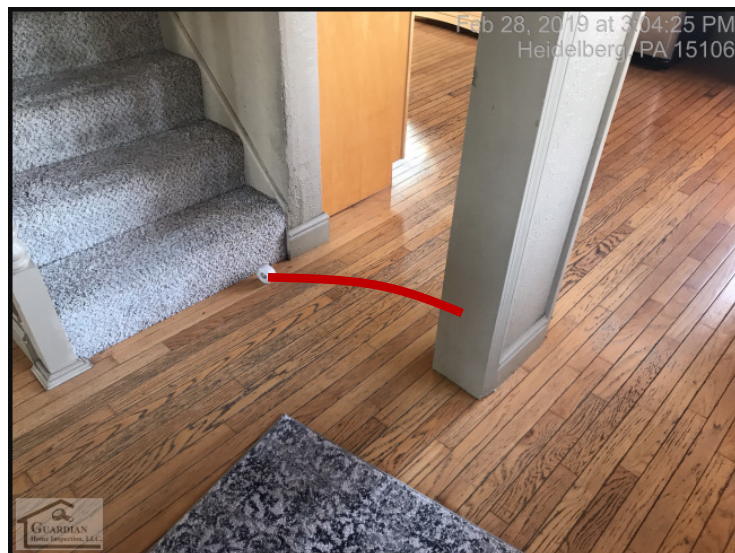
Figure 46 Areas of the flooring, along the first floor (at the base of the 1st floor stairway), are unlevel and sloping.

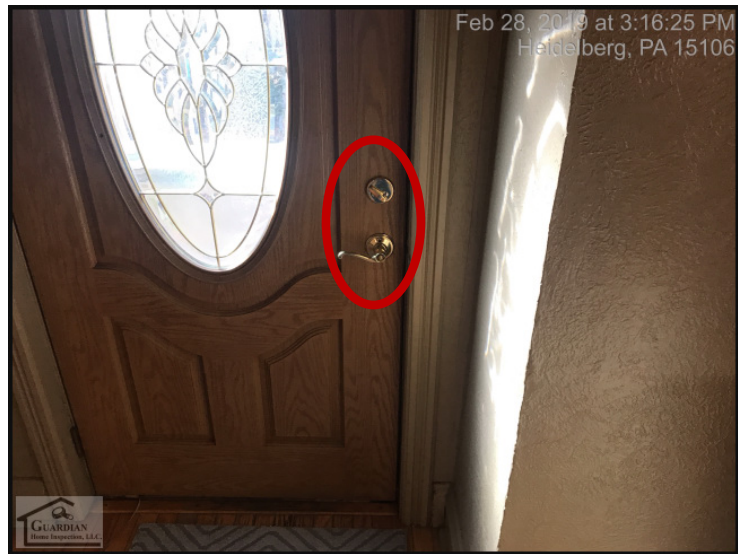
Figure 47 The locking hardware, on the west facing entry door, is need of repair (the dead bolt, latch and striker plate are misaligned preventing the door from locking).

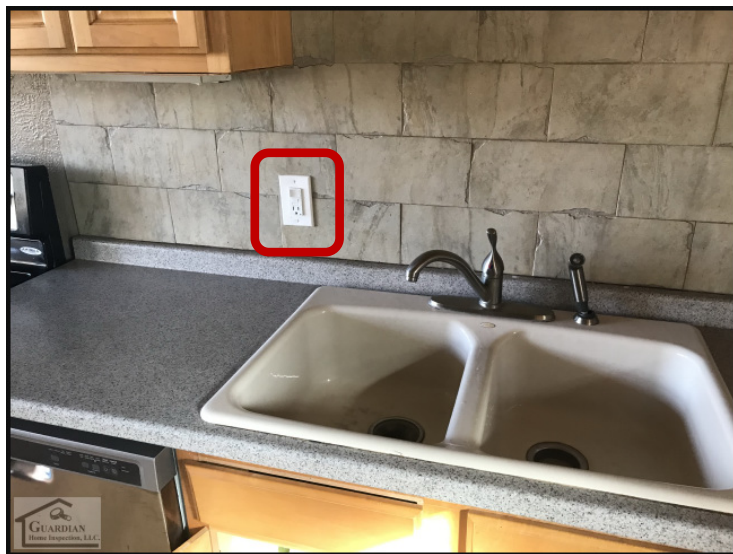
- **Safety Related Repair Item:** The ground fault circuit interrupter (GFCI) outlet, along the left-hand side of the kitchen sink, was inoperative (not tripping/resetting) at the time of inspection. This condition should be repaired by a qualified electrician.

Figure 48 The ground fault circuit interrupter (GFCI) outlet, along the left hand side of the kitchen sink, was inoperative (not tripping/resetting) at the time of inspection.

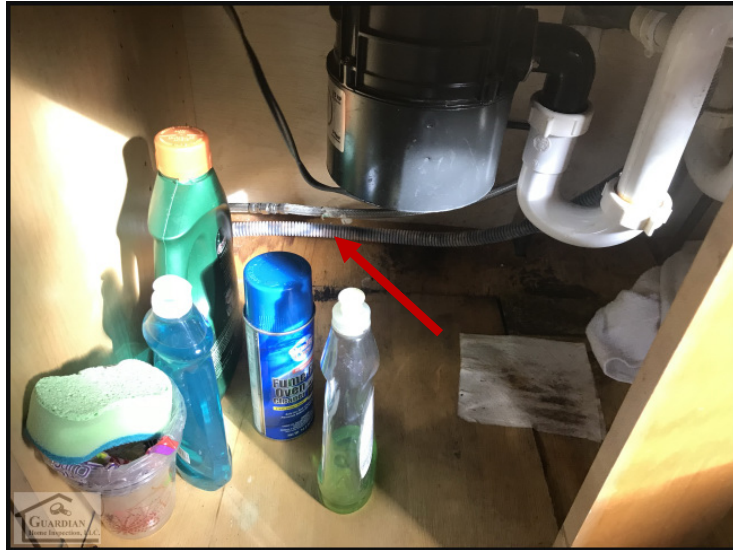
- **General Repair Item:** The dishwasher's discharge line has no visible high-loop installed. A high loop or air gap must be used to prevent potential backflow contamination of the dishwasher. Local plumbing codes generally dictate the requirements in your area. Listed airgaps shall be installed with the flood level (FL) marking at or above the flood level of the sink or drainboard, whichever is higher, or separately trapped with the air break located on the stand pipe.

Figure 49 The dishwasher's discharge line has no visible high-loop installed.

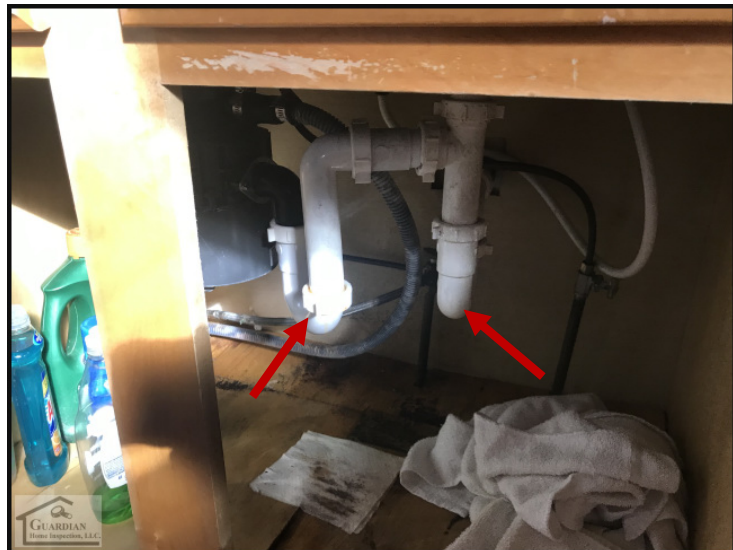
Figure 50 The drain lines, under the kitchen sink, are double trapped.

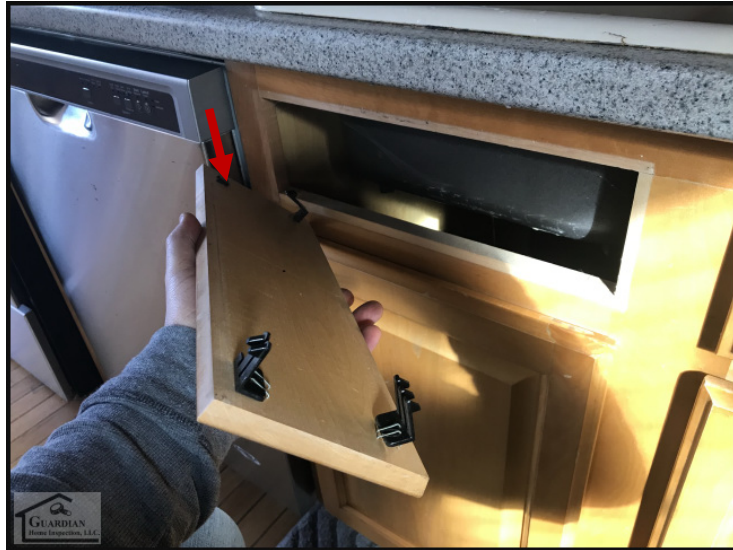
- **General Repair Item:** The retaining clip, on the cabinet face plate along the front of the kitchen sink, is damaged and in need or replacement (see photo).

Figure 51 The retaining clip, on the cabinet face plate along the front of the kitchen sink, is damaged and in need of replacement.

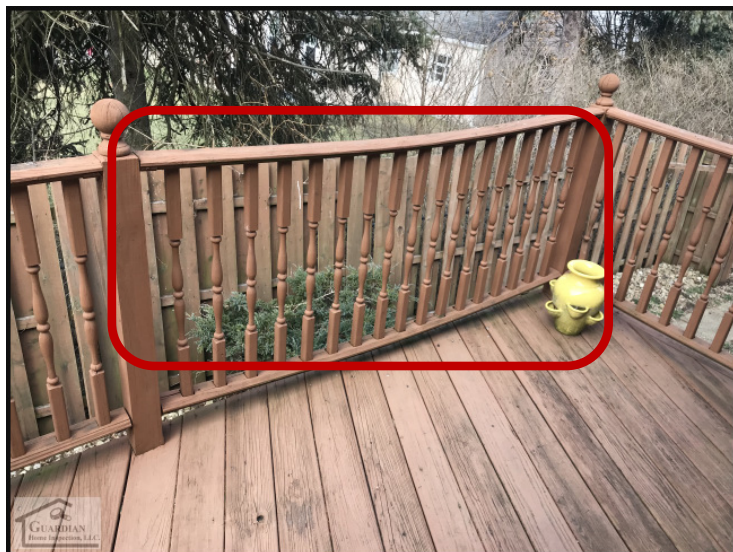
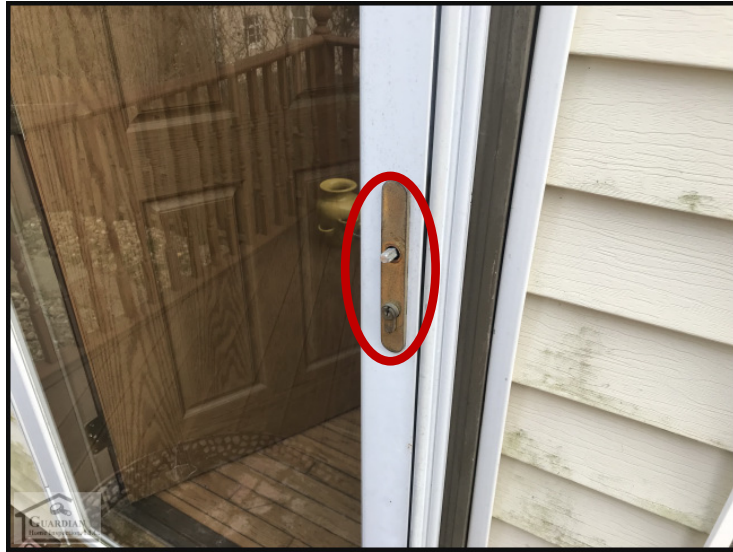
Figure 52 The door handle hardware, on the north facing storm door, is damage/missing.
