Residential Building Inspection Report

123 Any Road, Pittsburgh, PA 15123

Inspection Date: 01/29/2011

Report Number: 0135110912

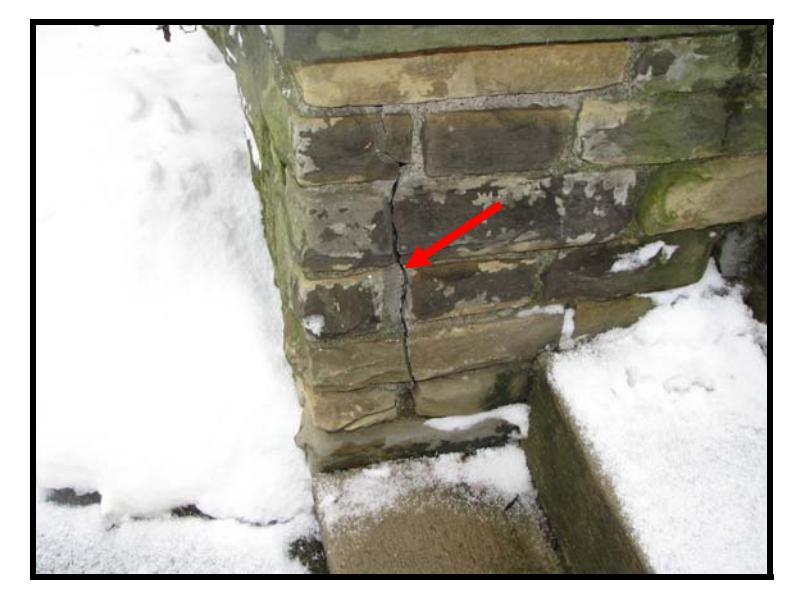
Figure 1 The retaining wall, along the front of the home, shows evidence of limited movement and cracking (see photo).

• **Repair:** The retaining wall, along the front of the home, shows evidence of limited movement and cracking (see photo). The damaged areas should be repaired by a qualified mason. In addition, the installation of weep-holes at its base or some other drainage provision to relieve pressure from behind would be a logical improvement. You should consult with a mason or landscape contractor before the expiration of your Inspection Objection Deadline to discuss various options and costs for repair or replacement.

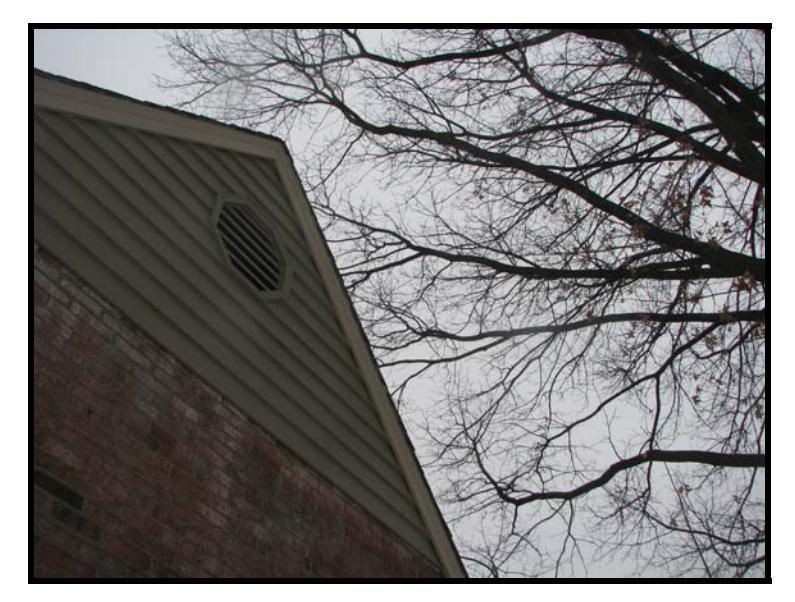
Figure 2 The tree branches, overhanging the roof, should be trimmed back to prevent debris from clogging gutters (see photo).

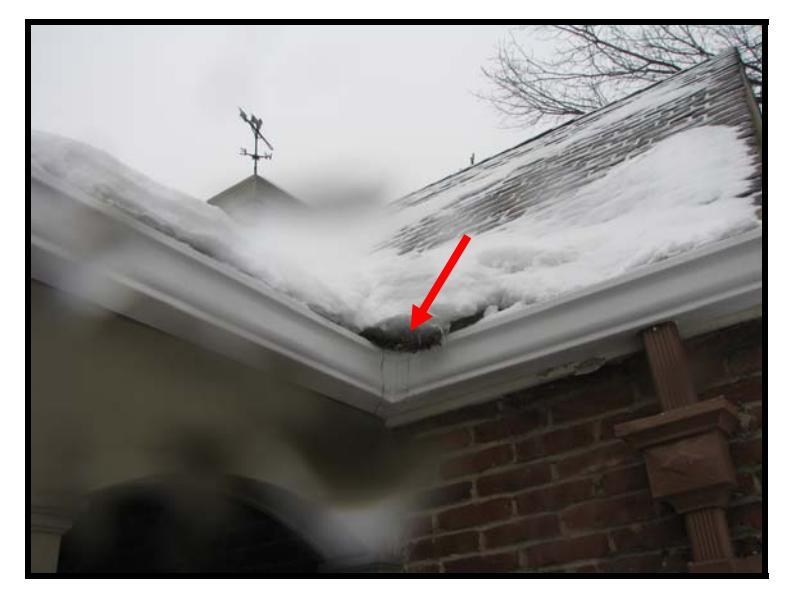
Figure 3 The gutters require cleaning to avoid spilling roof runoff around the building – a potential source of water entry or water damage.

• **Repair:** The gutters require cleaning to avoid spilling roof runoff around the building – a potential source of water entry or water damage.

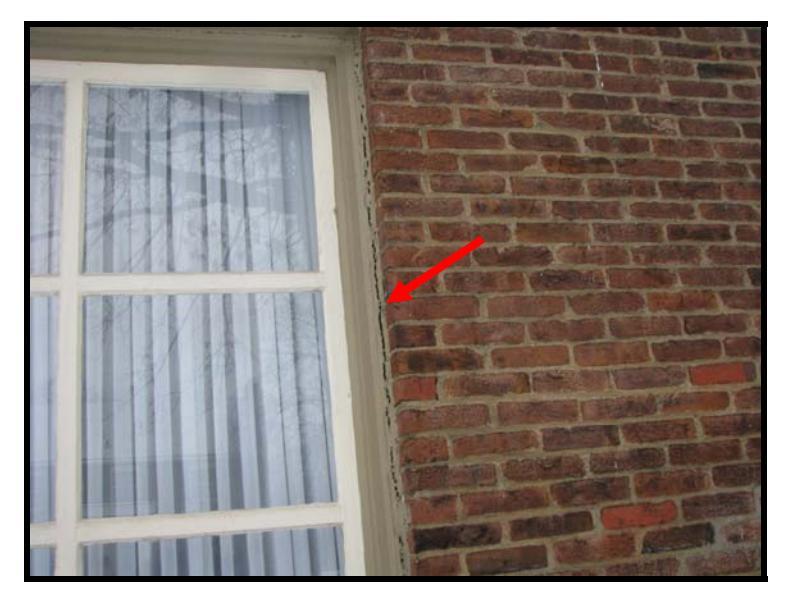
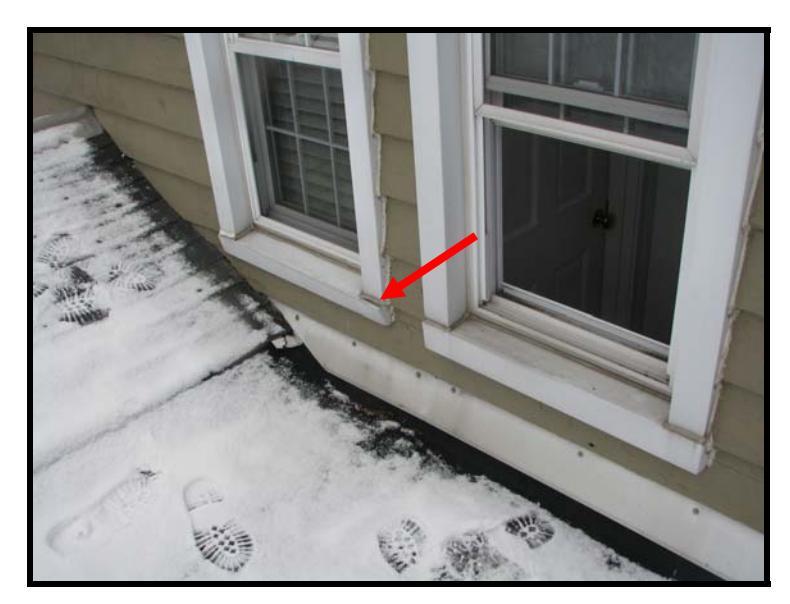
Figure 4 The window and door frames, throughout the exterior of the home, require caulking to prevent moisture intrusion of the interior wall assembly (see photo). Maintaining window exteriors on an annual basis will extend their lifespan.

Figure 5 The window and door frames, throughout the exterior of the home, require caulking to prevent moisture intrusion of the interior wall assembly (see photo). Maintaining window exteriors on an annual basis will extend their lifespan.

• **Repair:** The window and door frames, throughout the exterior of the home, require caulking to prevent moisture intrusion of the interior wall assembly (see photo). Maintaining window exteriors on an annual basis will extend their lifespan.

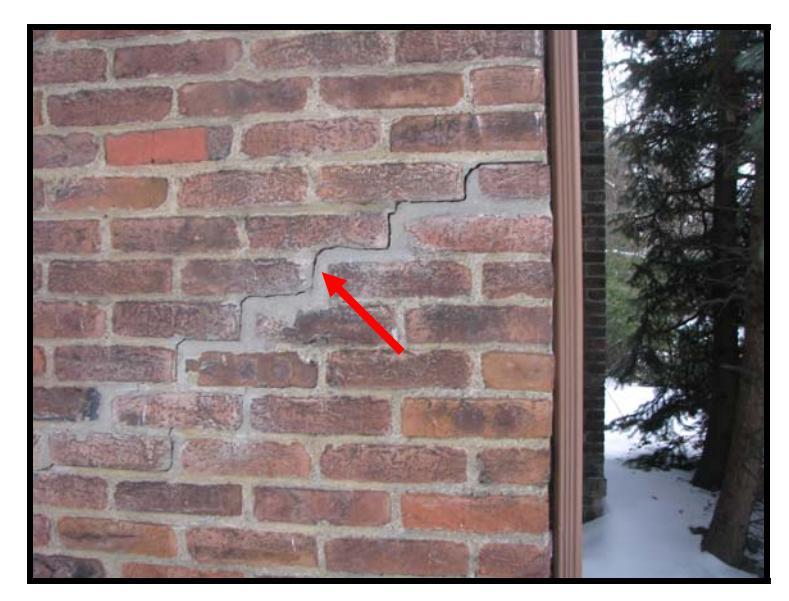
Figure 6 A limited amount of cracking was observed along the front right exterior corner of the brick veneer (see photo). This type of cracking is most likely due to a limited amount of settlement that has occurred.

- **Repair:** A limited amount of cracking was observed along the front right exterior corner of the brick veneer (see photo). This type of cracking is most likely due to a limited amount of settlement that has occurred. The rate of movement cannot be predicted during a one time inspection; however these cracks should be repaired and monitored closely for additional movement. If movement continues, more significant repairs may be required. Consult a qualified mason for repairs.

- **Repair:** A limited amount of cracking was observed along the front right exterior corner of the brick veneer (see photo). This type of cracking is most likely due to a limited amount of settlement that has occurred. The rate of movement cannot be predicted during a one time inspection; however these cracks should be repaired and monitored closely for

additional movement. If movement continues, more significant repairs may be required. Consult a qualified mason for repairs.

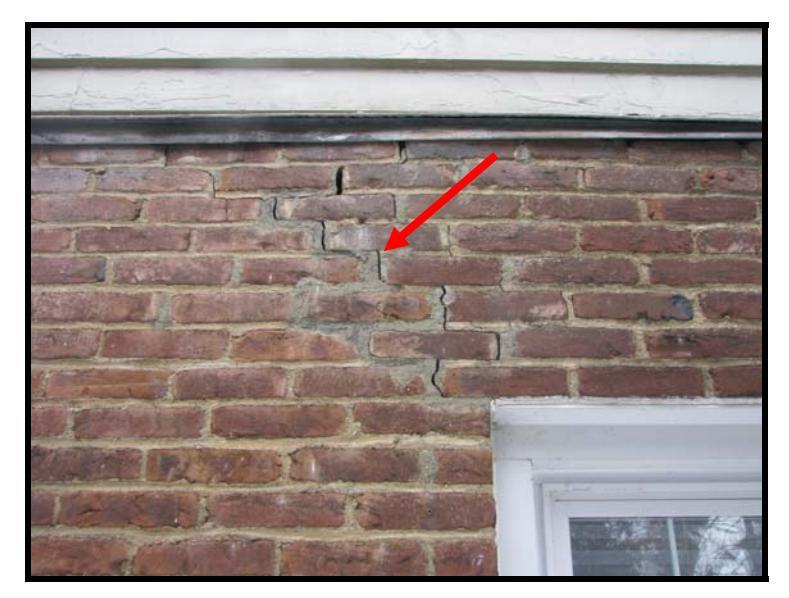
Figure 7 A limited amount of step type cracking was observed along the mortar joints on the exterior brick veneer walls where several windows and the garage door exist (see photos).

- **Repair:** A limited amount of step type cracking was observed along the mortar joints on the exterior brick veneer walls where several windows and the garage door exist (see photos). The cause of this type of separation is due to the supporting steel lintels rusting and expanding in volume. This jacking action on the surrounding block ultimately causes fractures and deterioration of the mortar in contact with the lintels. The cracks should be tuck-pointed and the lintels should be painted with a rust-inhibiting paint and caulked annually. Consult a qualified mason for further information and repair options.

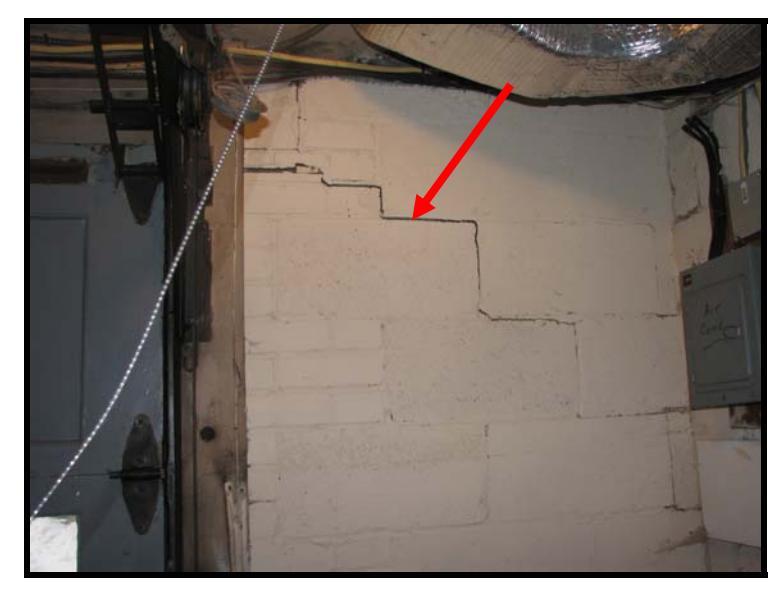
Figure 8 Separation has occurred along the mortar joints in the garage due to the rusting and consequential expanding steel lintel.

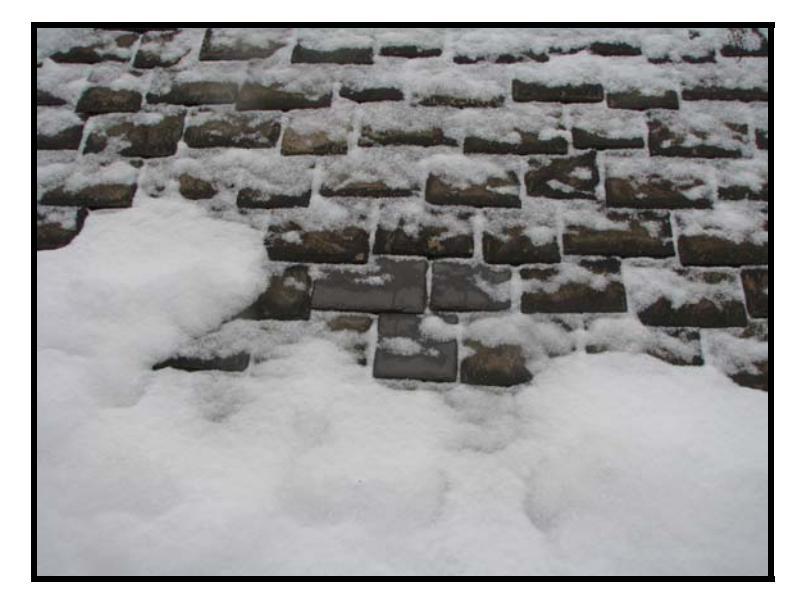
Figure 9 All visible roof components appeared to be in serviceable condition at the time of the inspection.

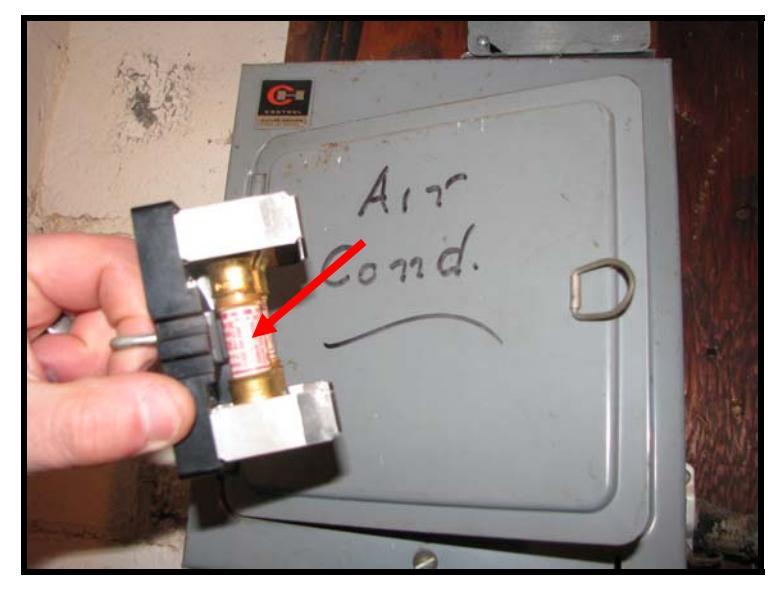
Figure 10 The 30 amp cartridge fuses, servicing the air conditioning unit, are undersized (see photo). The service tag on the AC unit requires a minimum of 35 amp fuses.

- **Repair:** The 30 amp cartridge fuses, servicing the air conditioning unit, are undersized (see photo). The service tag on the AC unit requires a minimum of 35 amp fuses.
- **Repair:** One opening was observed along the top of the electrical sub-panel (see photo). Unfilled holes or knockouts in the electrical service sub-panel may allow persons to come into contact with energized electrical components. This condition is a potential shock/electrocution hazard and should be corrected by a qualified electrical contractor.

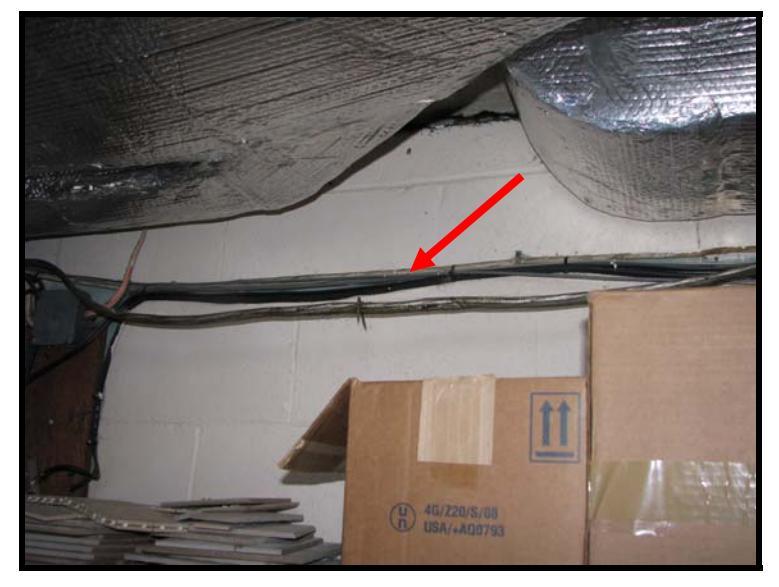
Figure 11 The unsecured electrical branch wiring in the garage should be properly secured (see photo).

- **Repair:** The damaged exterior electrical branch wiring, servicing the air conditioning unit, should be replaced (see photo). The Inspector recommends correction by a qualified electrical contractor.
- **Repair:** The unsecured electrical branch wiring in the garage should be properly secured (see photo). According to the NEC (National Electrical Code) wiring should be stapled to wood framing members or secured with hangers within 12" on both sides of all enclosures (panels, junction boxes, switches, outlets, and fixtures). Wiring beyond the first secured point next to enclosures should be stapled or secured every 4 ½ along the length of the circuit. Recommend that this repair be done by a certified electrician.

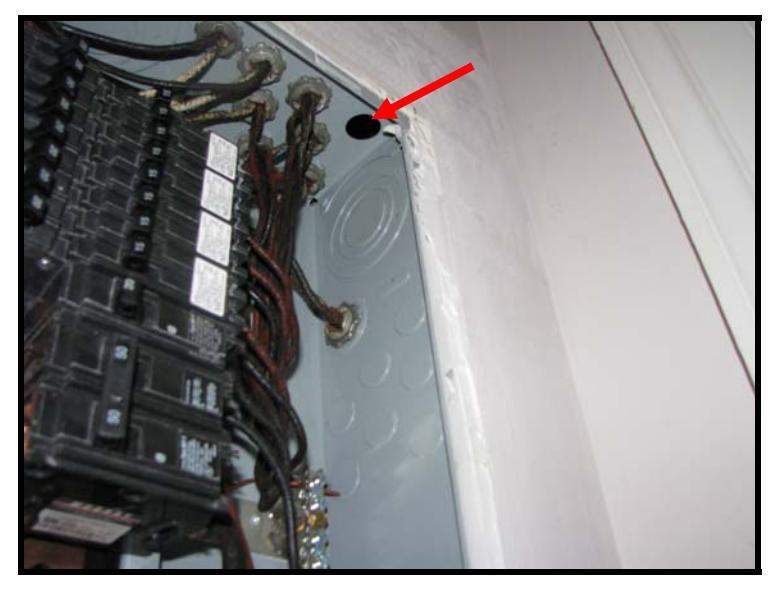
Figure 12 One opening was observed along the top of the electrical sub-panel (see photo). Unfilled holes or knockouts in the electrical service sub-panel may allow persons to come into contact with energized electrical components.

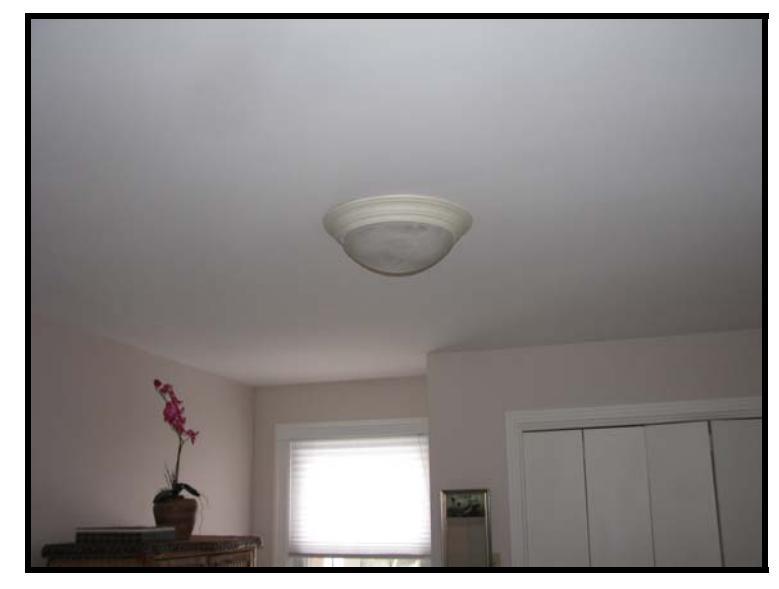
Figure 13 The light fixture, along the rear left bedroom ceiling, would not operate at the time of inspection (see photo). If the bulbs are not blown, the circuit should be repaired.

• **Repair:** The light fixture, along the rear left bedroom ceiling, would not operate at the time of inspection (see photo). If the bulbs are not blown, the circuit should be repaired.

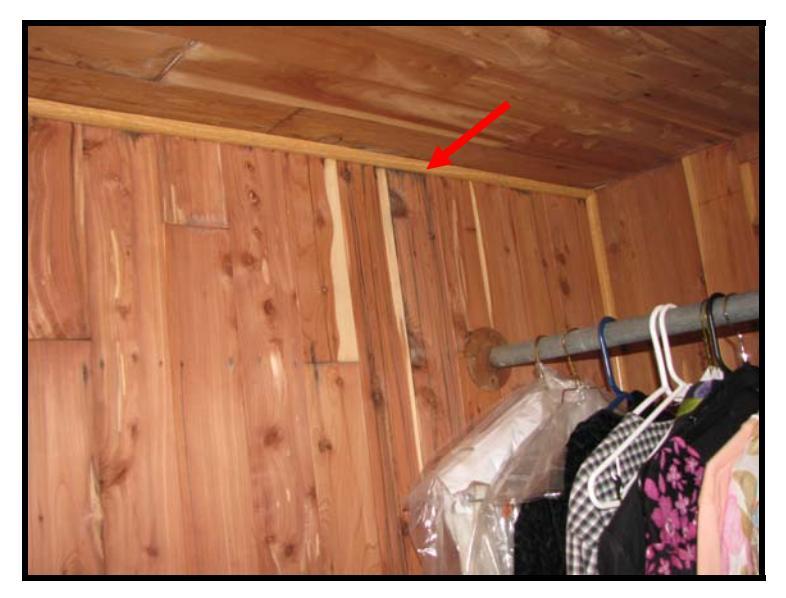
Figure 14 Active moisture staining was observed and tested utilizing a protimeter (moisture meter) along the interior front facing cedar closet in the basement (see photo).

- **Repair:** Active moisture staining was observed and tested utilizing a protimeter (moisture meter) along the interior front facing cedar closet in the basement (see photo). The exact cause of the moisture could not be identified; however it is most likely due to a combination of conditions such as the exterior retaining wall/planter area (which is retaining moisture), deteriorated exterior caulking along the window frames, and the clogged/ice filled gutters. Repairs and/or improvements to the aforementioned items will help to prevent further moisture penetration.

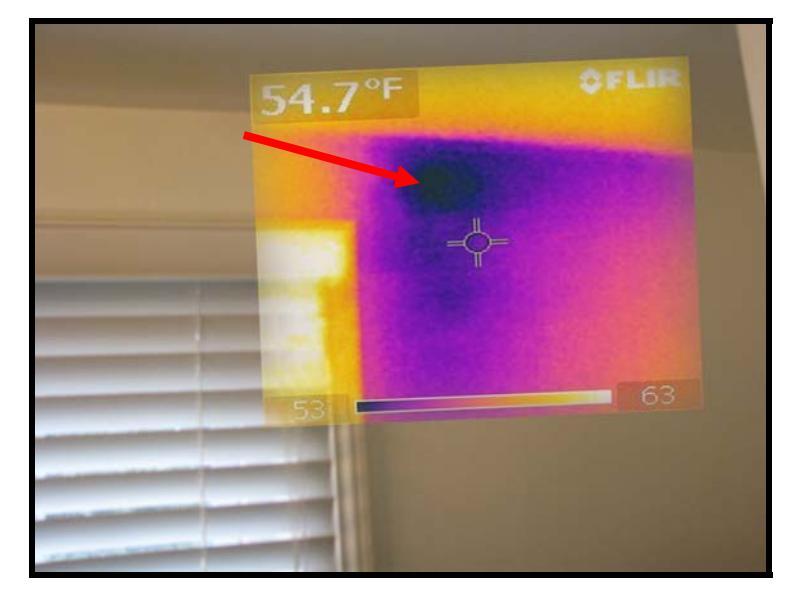
Figure 15 Active moisture staining was observed and tested utilizing a protimeter (moisture meter) along the interior second floor bathroom wall/ceiling area (the purple area, on thermal image, showing where active moisture exists behind the wall).

- **Repair:** Active moisture staining was observed and tested utilizing a protimeter (moisture meter) along the interior second floor bathroom wall/ceiling area and along the upper right corner of the interior chimney chase in the step down living room (see photos). Both areas are adjacent to the chimneys indicating a problem with the chimney flashings failing to adequately direct rainwater away from the home's interior. Repairs to the chimney flashings are needed; consult a qualified roofer for repairs.

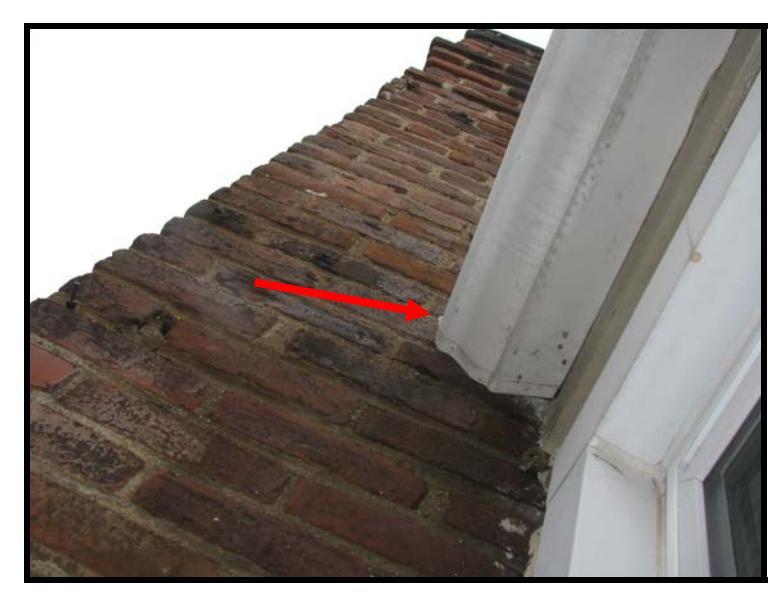
Figure 16 The chimney flashings in this area are in need of resealing.

• **Repair:** The protimeter (moisture meter) detected active moisture along the interior ceiling areas adjacent to both chimneys (see Interior Section). The cause of this moisture is most likely due to the chimney flashings failing to adequately direct water away from the interior living space. The chimney flashings should be resealed; consult a qualified roofer for repairs.

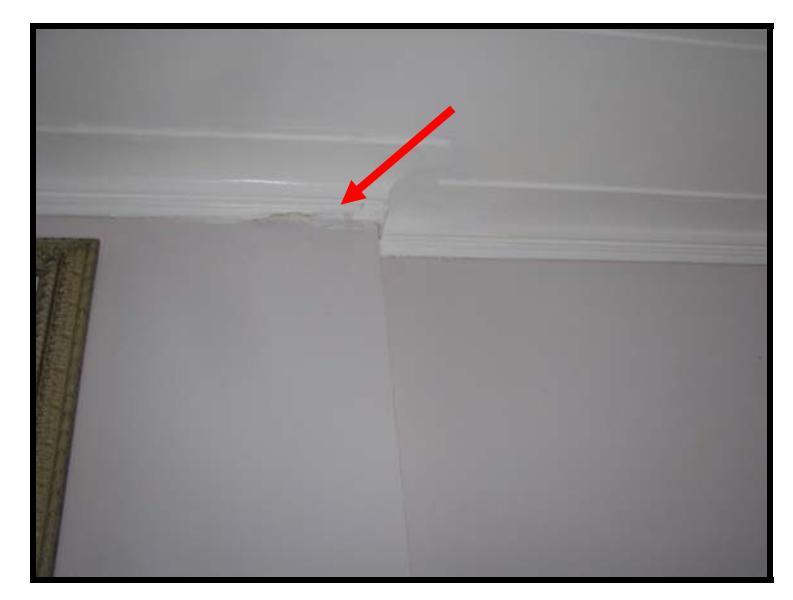
Figure 17 Active moisture staining was observed and tested utilizing a protimeter (moisture meter) along the upper right corner of the interior chimney chase in the step down living room (see photos).

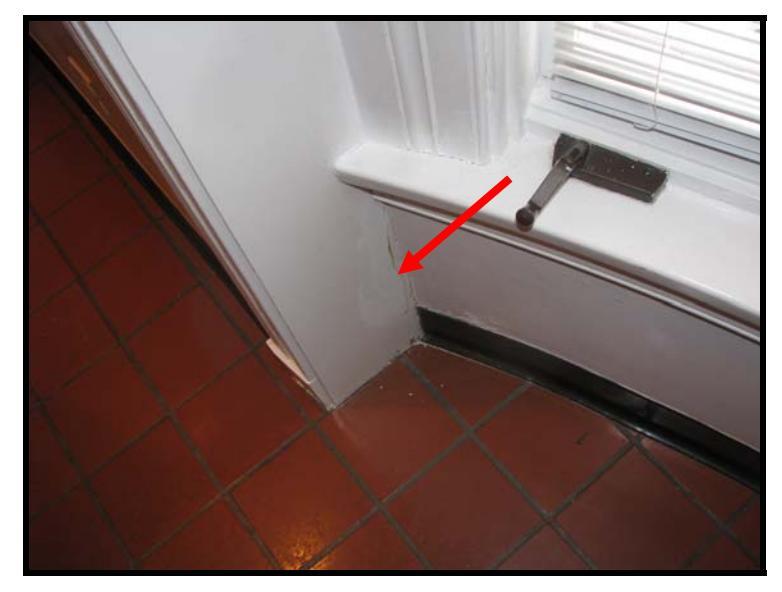
Figure 18 Active moisture staining was observed and tested utilizing a protimeter (moisture meter) along the interior front facing kitchen wall (below the bay window - see photo). The cause of the moisture appears to be due to openings along the exterior window framing.

- **Repair:** Active moisture staining was observed and tested utilizing a protimeter (moisture meter) along the interior front facing kitchen wall (below the bay window see photo). The cause of the moisture appears to be due to openings along the exterior window frame (see also Exterior Section).

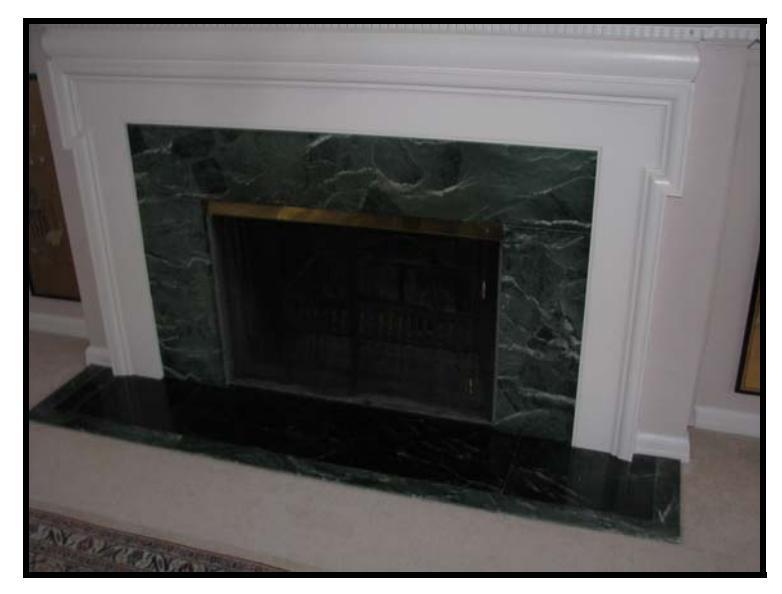
Figure 19 The fireplace damper is not seated correctly and requires adjustment for proper operation.

• Improve: The fireplace damper is not seated correctly and requires adjustment for proper operation (see photo).

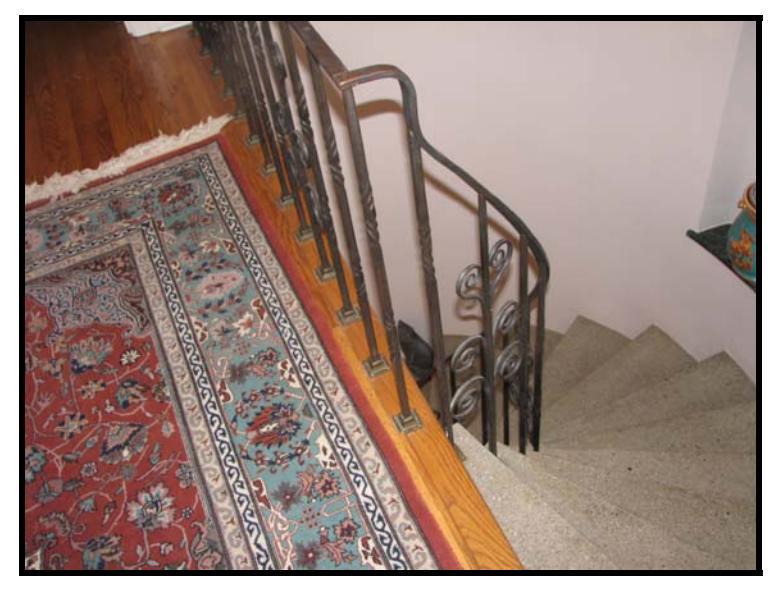
Figure 20 The second floor stairway hand and guard rail is loose/not well secured and may pose a safety concern (see photo).

• **Repair:** The second floor stairway hand and guard rail is loose/not well secured and may pose a safety concern (see photo).

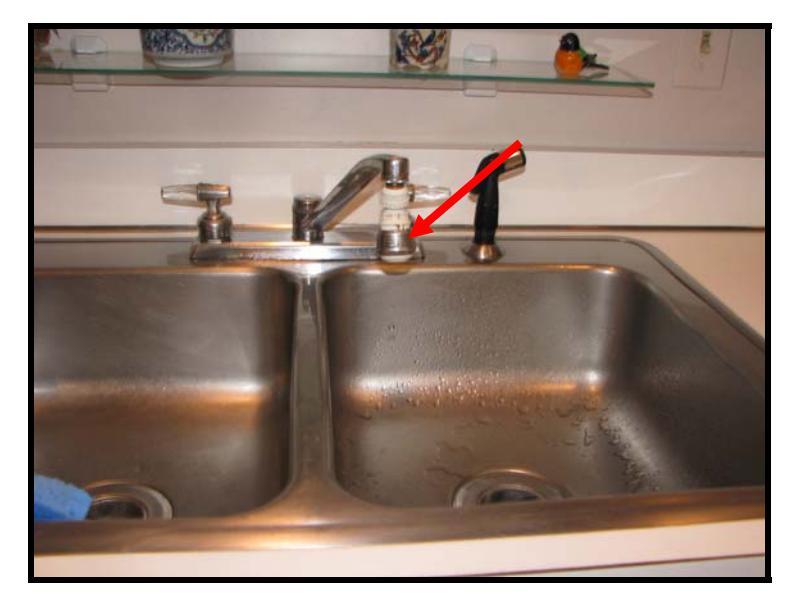
Figure 21 The kitchen faucet was actively dripping at the time of inspection (see photo). Dripping usually occurs when the O-ring inside the faucet's aerator has worn out or broken.

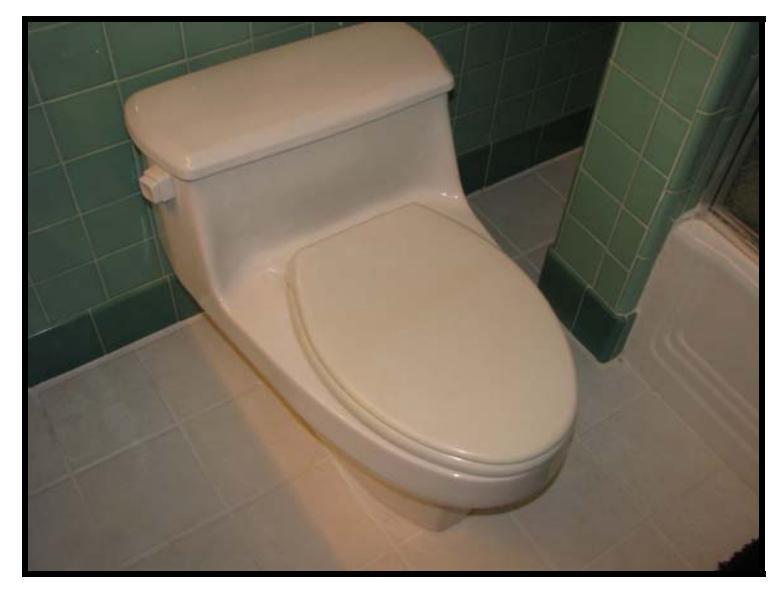
Figure 22 The toilet, on the second floor, is loose from the floor (see photo). A moderate tightening of the bolts will usually eliminate all movement.

- **Repair:** The toilet, on the second floor, is loose from the floor (see photo). A moderate tightening of the bolts will usually eliminate all movement. Loose toilet fixtures often conceal leakage at the seal. If the subfloor is constructed of wood, moisture seepage at the seal can result is serious damage to wood members. To ensure against fungus and dryrot repairs, replacement of the wax seal is a wise precautionary procedure when repairing loose toilets.
- **Repair:** The kitchen faucet was actively dripping at the time of inspection (see photo). Dripping usually occurs when the O-ring inside the faucet's aerator has worn out or broken. Left unchecked, a dripping kitchen faucet can have a significant impact on the water bill. Consult a qualified plumber for repairs.

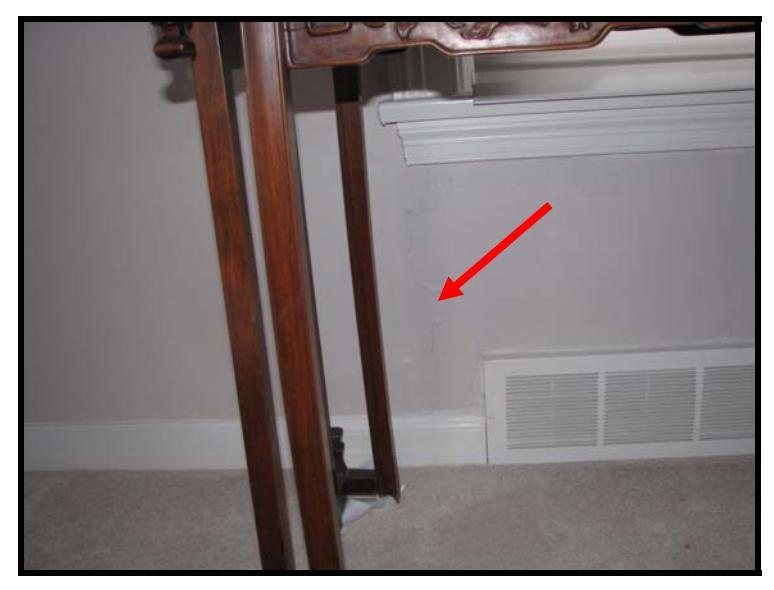
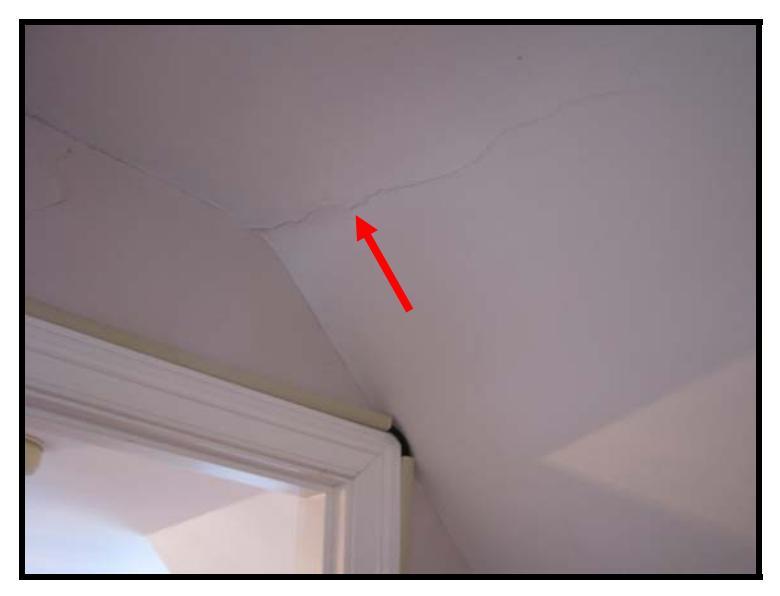
Figure 23 Minor cosmetic cracking was observed along the bedroom ceiling and right facing living room walls (see photos).

Figure 24 Minor cosmetic cracking was observed along the bedroom ceiling and right facing living room walls (see photos).

• **Improve:** Minor cosmetic cracking was observed along the bedroom ceiling and right facing living room walls (see photos). These cracks are most likely due to a limited amount of settling that has occurred in the past (see also Exterior Section) and pose no structural concern. Improvements will be necessary prior to painting.
